COUNTY OF LEHIGH

SPILLMAN FARMER ARCHITECTS  
MASONRY PRESERVATION SERVICES  
KEAST & HOOD STRUCTURAL ENGINEERS

## SAYLOR CEMENT KILNS COPLAY, PENNSYLVANIA

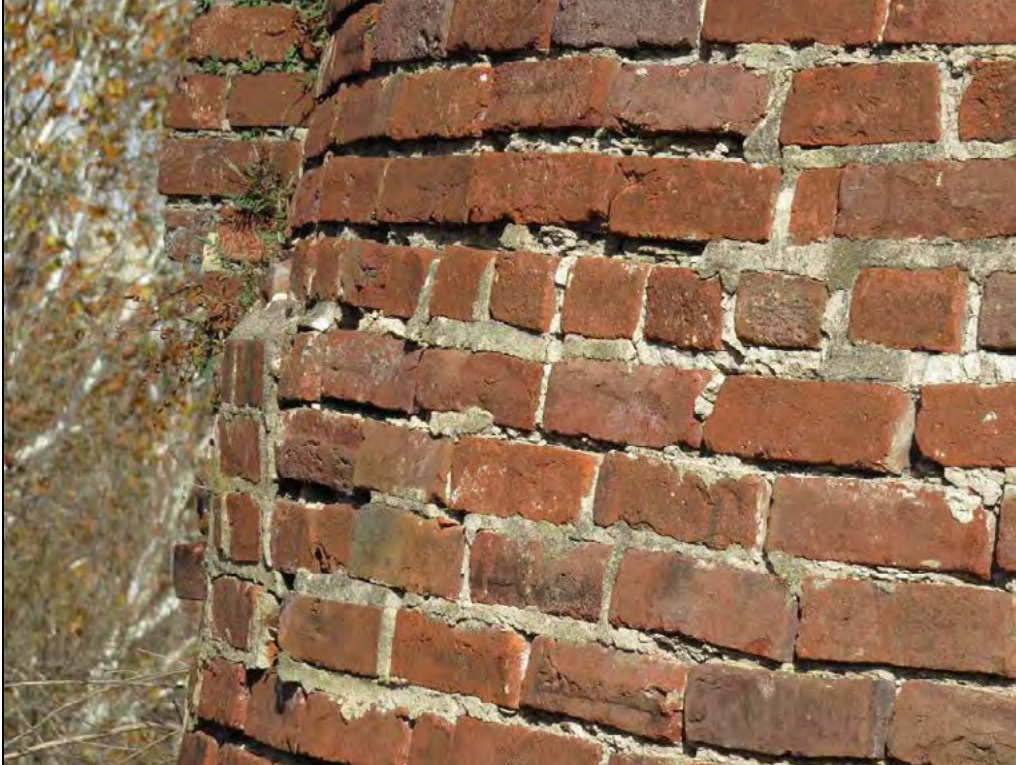
**Photograph 11:**

Open mortar joints  
and displaced  
brick.

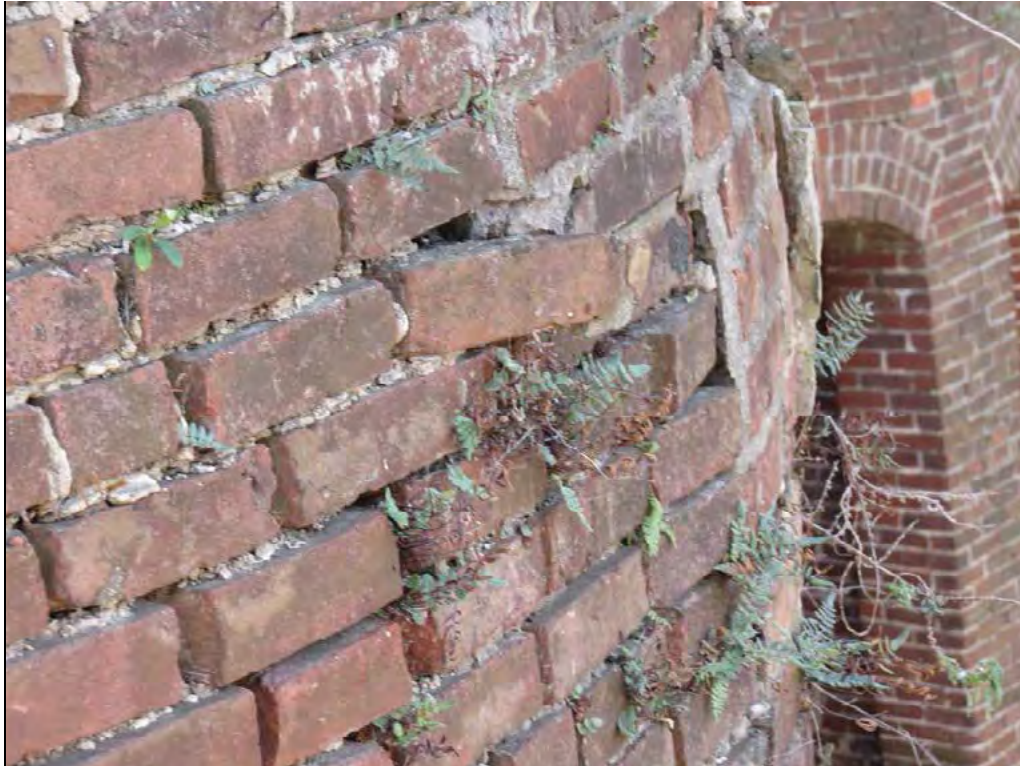
**Photograph 12:**

The mortar joints are so deteriorated brick is coming loose from the wall.

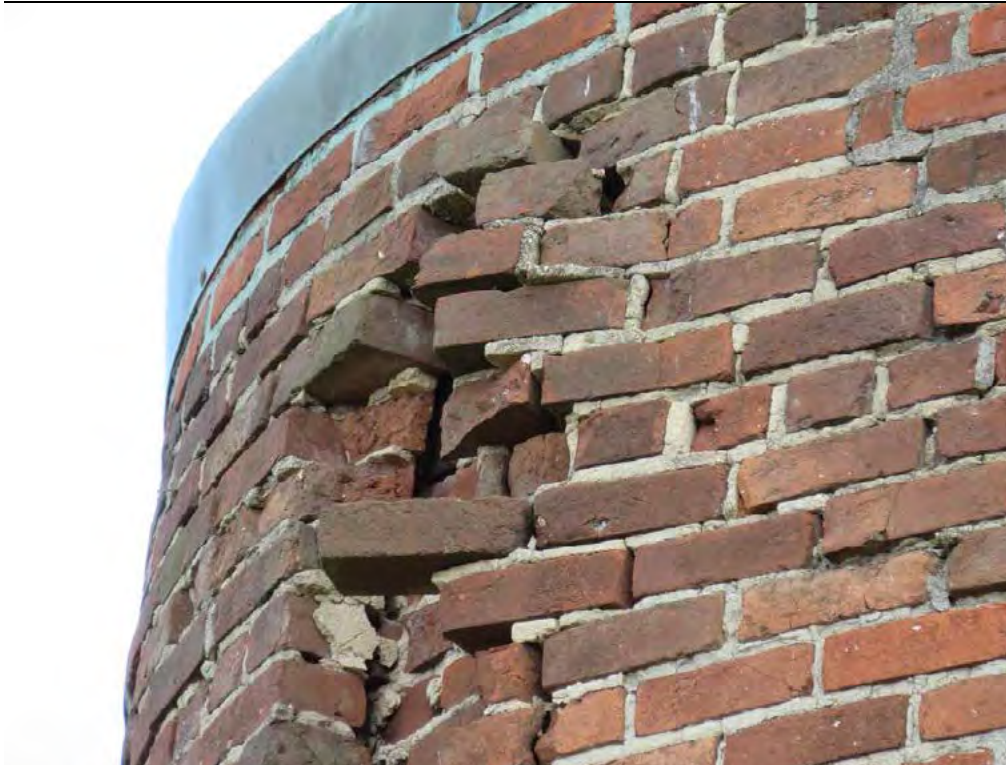
**Photograph 14:**

Extensive brick displacement will eventually lead to collapse of a large section of the brick veneer.

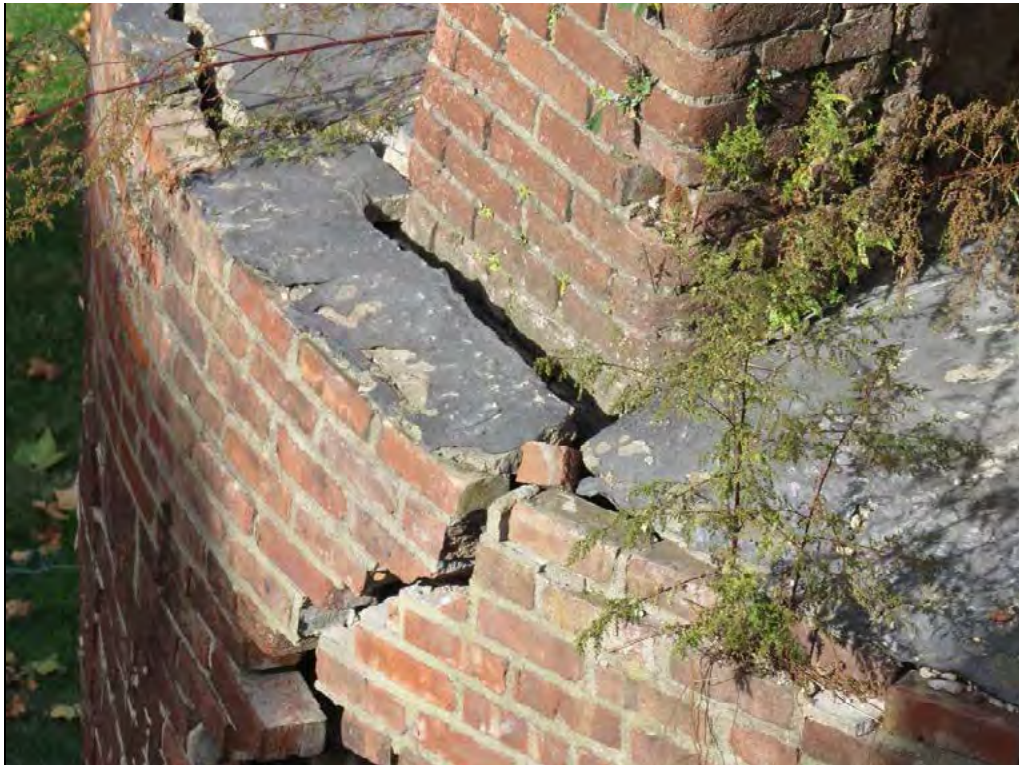
**Photograph 13:**

The brick veneer is separating from the back-up wall.

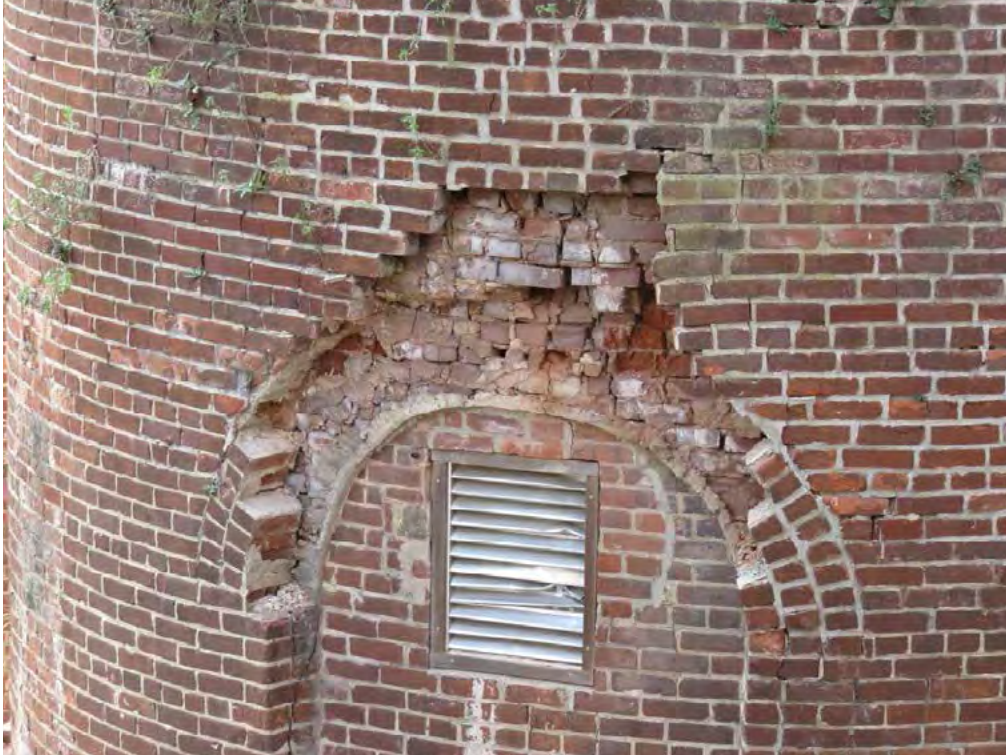
**Photograph 15:**

Large section of the brick veneer has come loose and fallen to the ground.

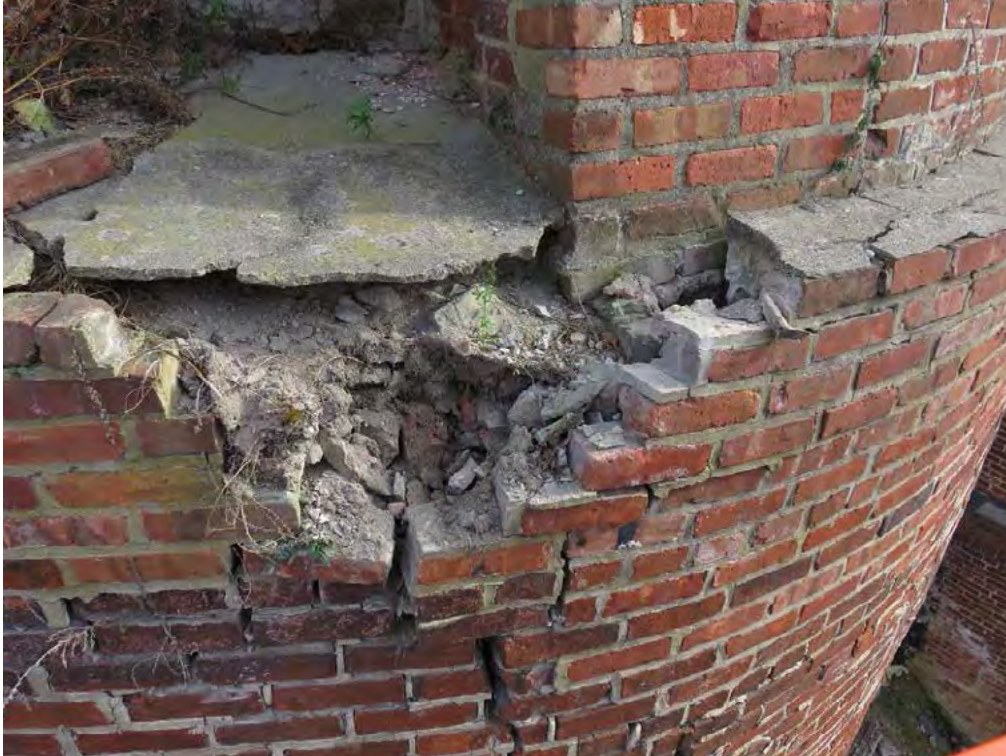
**Photograph 16:**  
The loss of the brick veneer creates large openings for bulk rain water to enter the wall assembly, increasing the rate of deterioration.

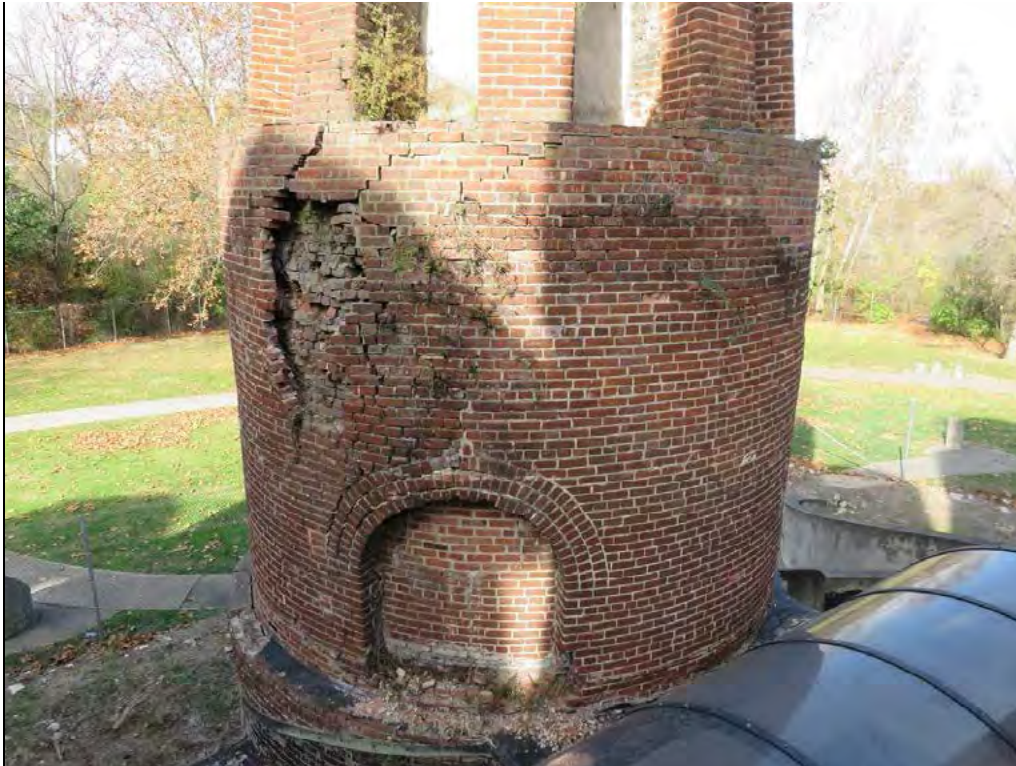
**Photograph 17:**  
Complete failure of  
the brick veneer.

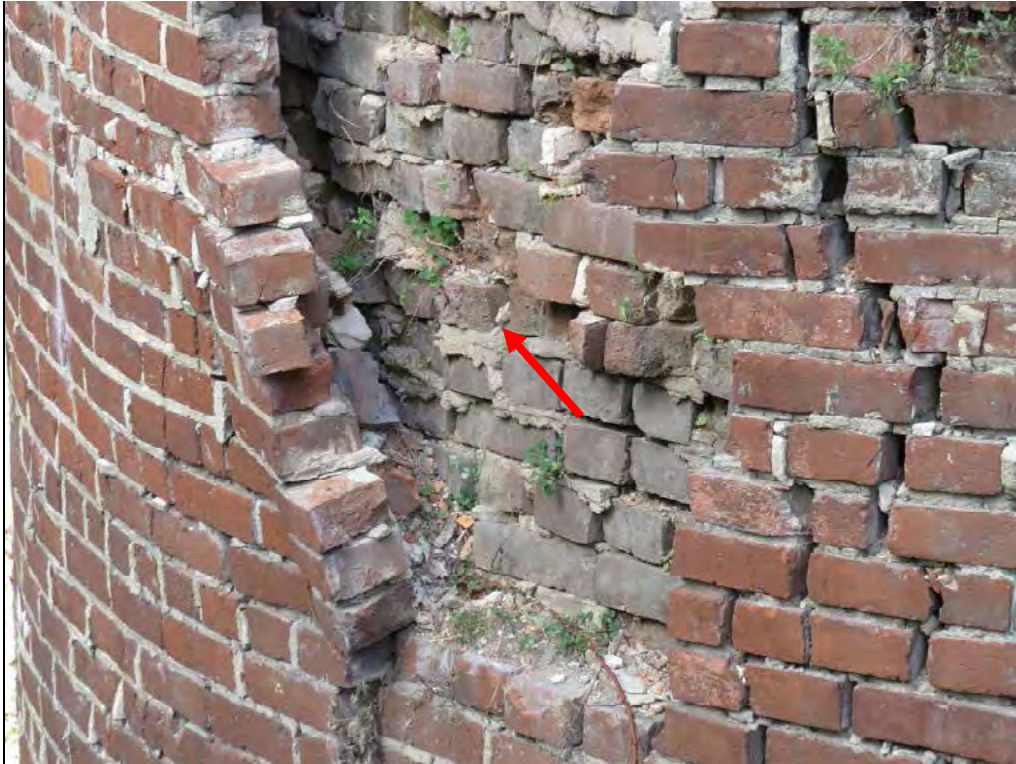
**Photograph 18:**

The brick veneer is pulling away from the back-up wall. Note the cracked headers where the brick came loose and fell to the ground.

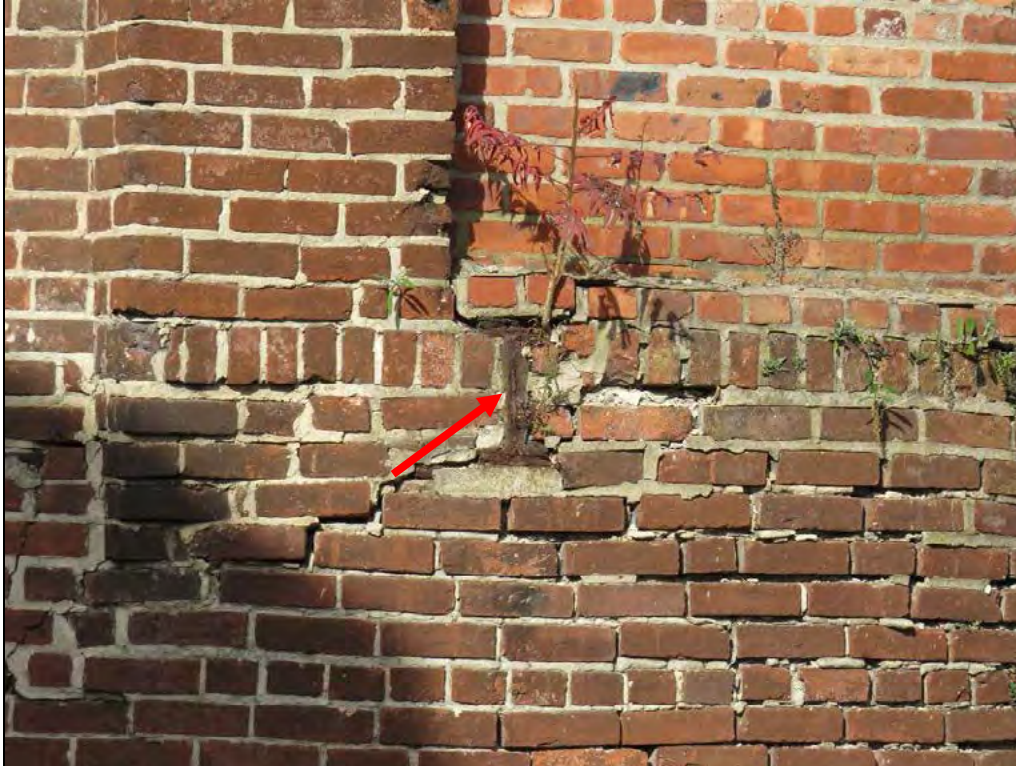
**Photograph 25:**  
The embedded steel beams still remaining are heavily corroded and causing displacement of the surrounding masonry.

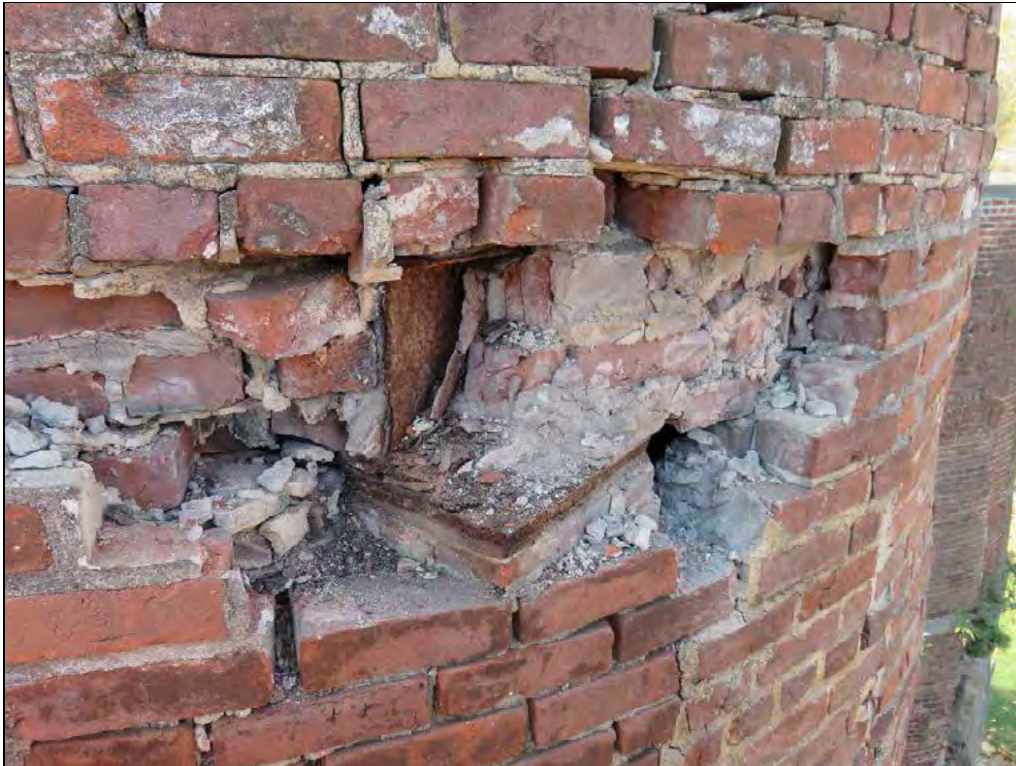
**Photograph 26:**  
The embedded  
steel beam was  
heavily corroded.

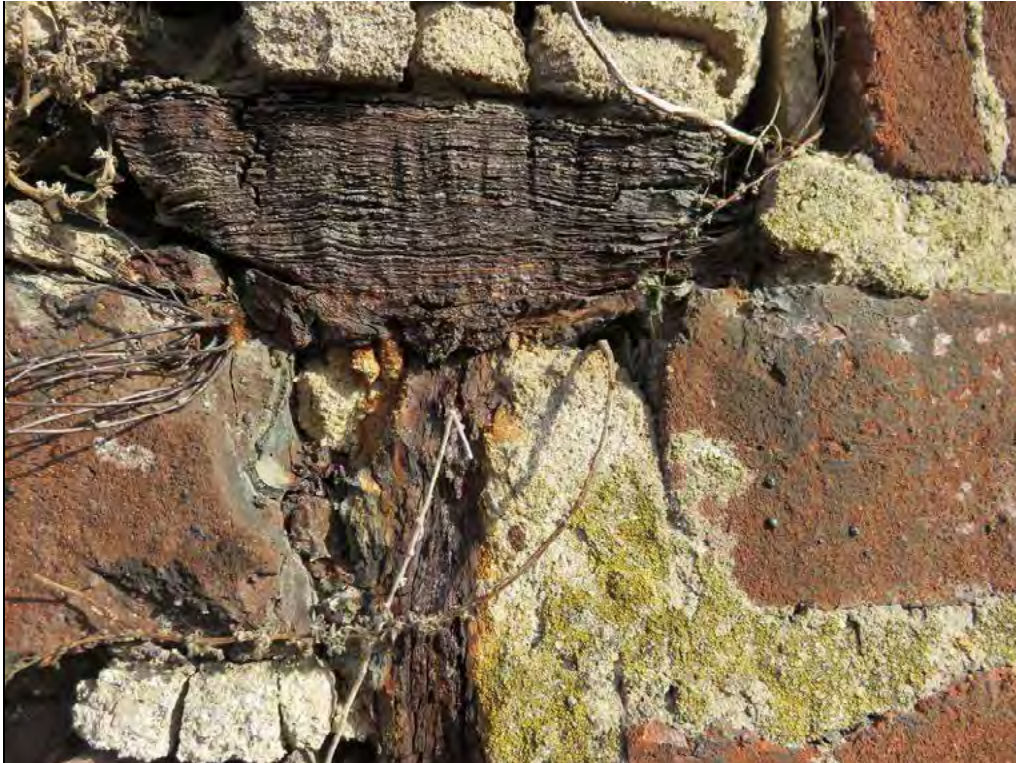
**Photograph 27:**  
The expansion of the steel as it corrodes puts stress on the surrounding masonry. This steel beam has expanded to be multiple times larger than it was originally.

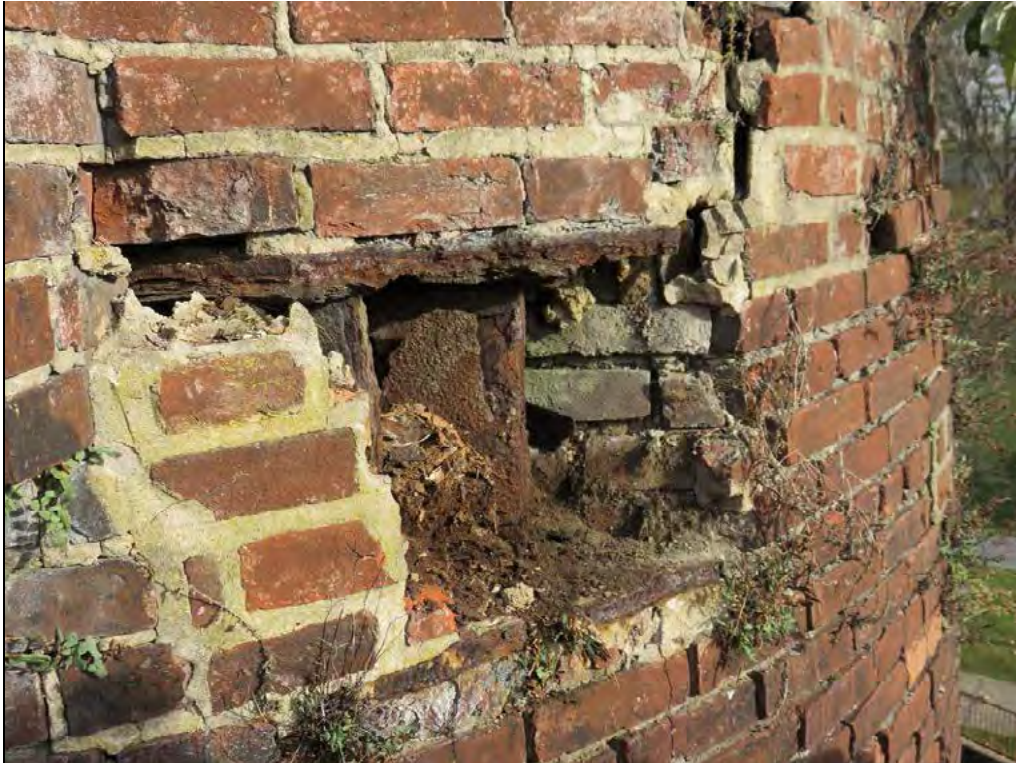
**Photograph 28:**

Another heavily corroded beam. Note that new brick was installed at this location, but without addressing the steel the deterioration continued.

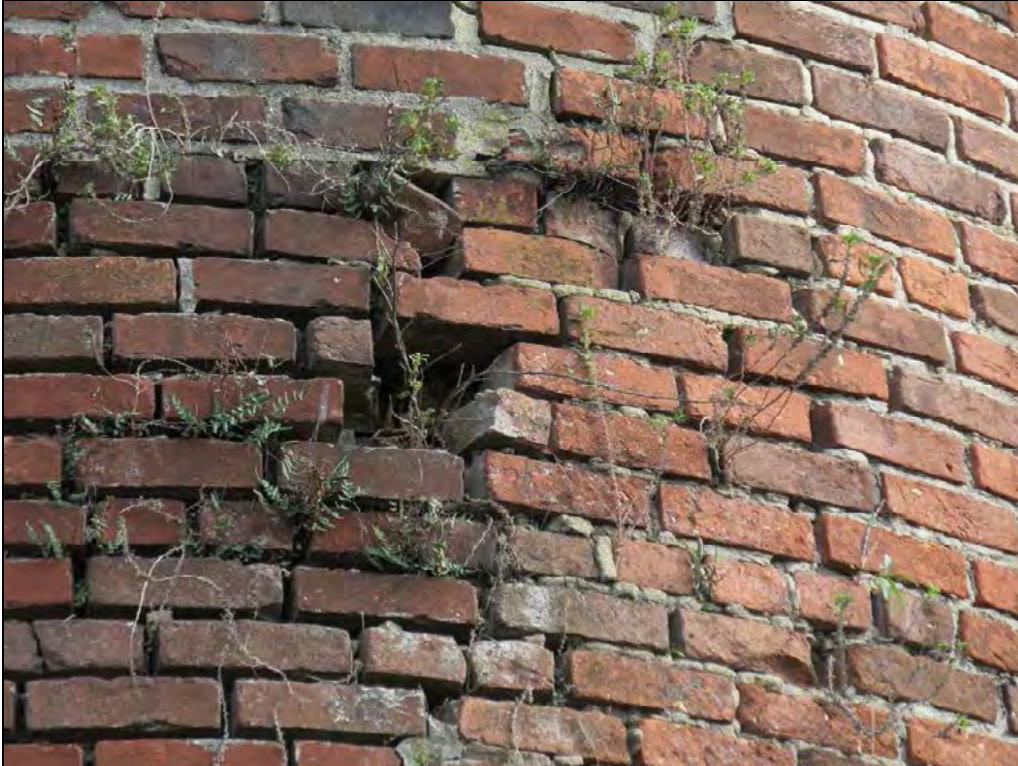
**Photograph 21:**  
Plant growth is  
present on each of  
the kilns.

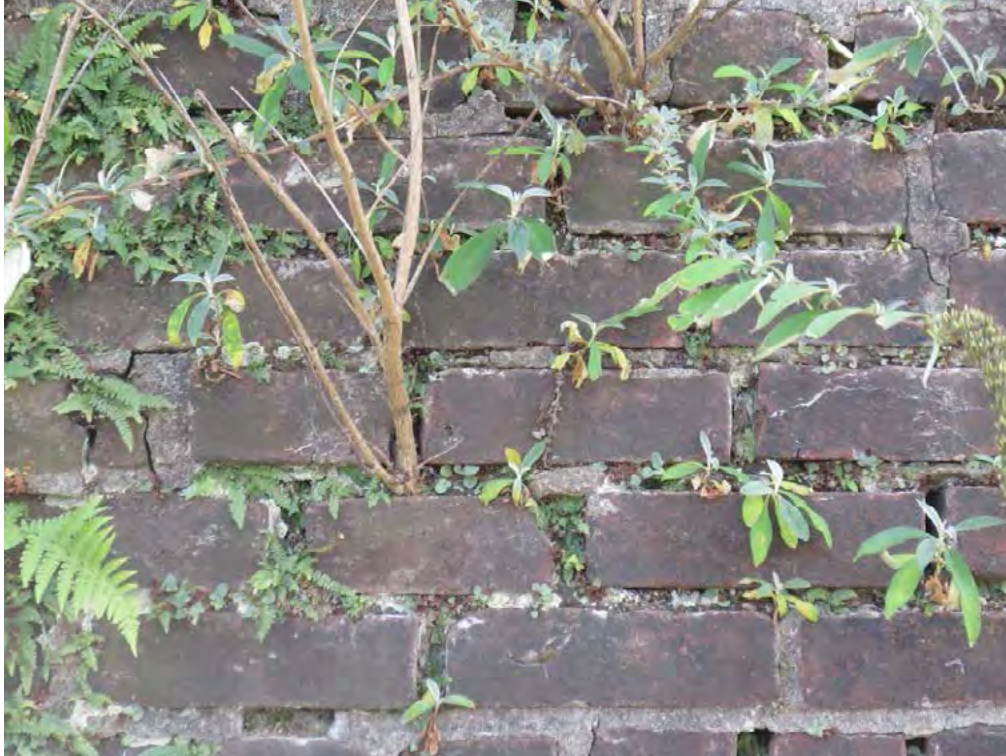
**Photograph 22:**  
The roots of the plants take hold in the missing mortar joints and expand as they grow.

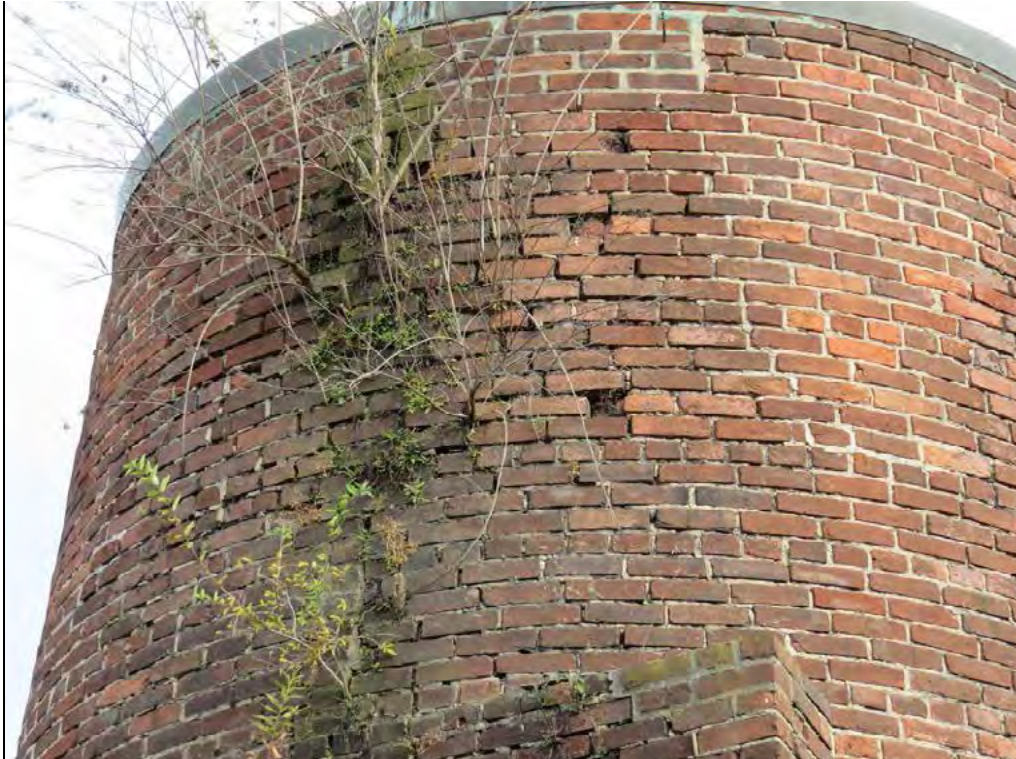
**Photograph 23:**  
As the plants get bigger the masonry deterioration surrounding the areas increases.

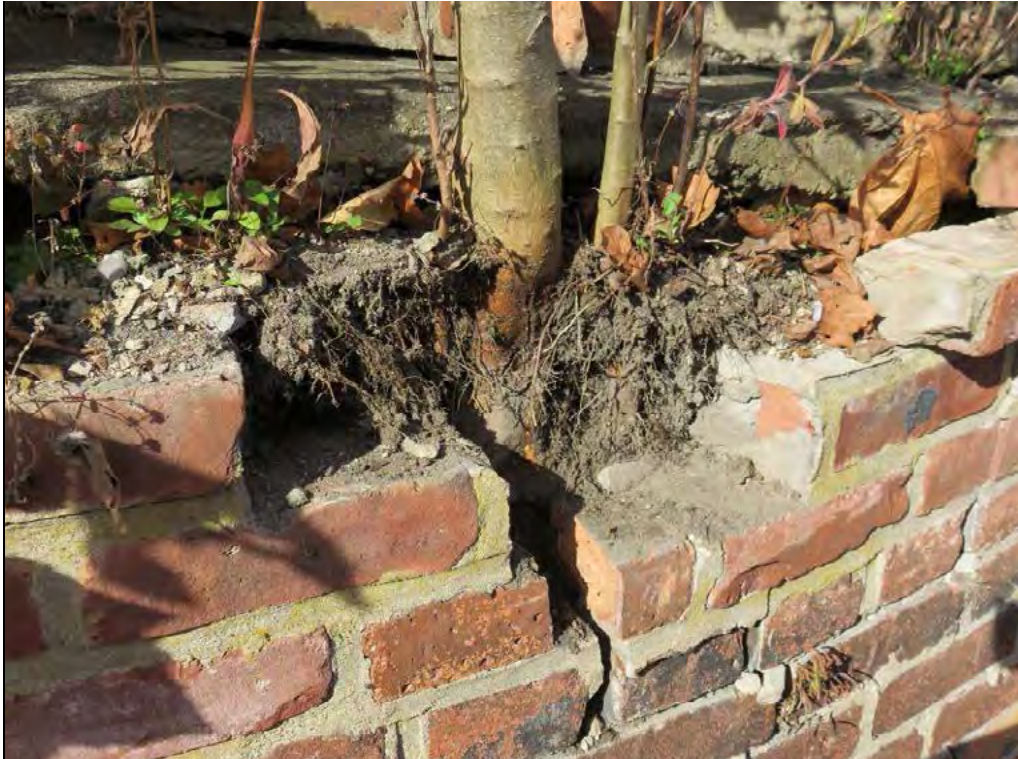
**Photograph 24:**  
Eventually the roots get large enough to cause displacement of the surrounding masonry.
