LEHIGH COUNTY BRIDGE NO. 6
LOCATION: SOUTH WHITEHALL TOWNSHIP
WEHR'S BRIDGE
WEHR MILL ROAD OVER JORDAN CREEK
CUSTODIAN: LEHIGH COUNTY

BMS NO. 39710305979006

DATE OF INSPECTION: MAY 10, 2011
INSPECTOR: SCOTT KLINE
DAVE ZIEGLER

Confidential - Structure Safety Inspection Study

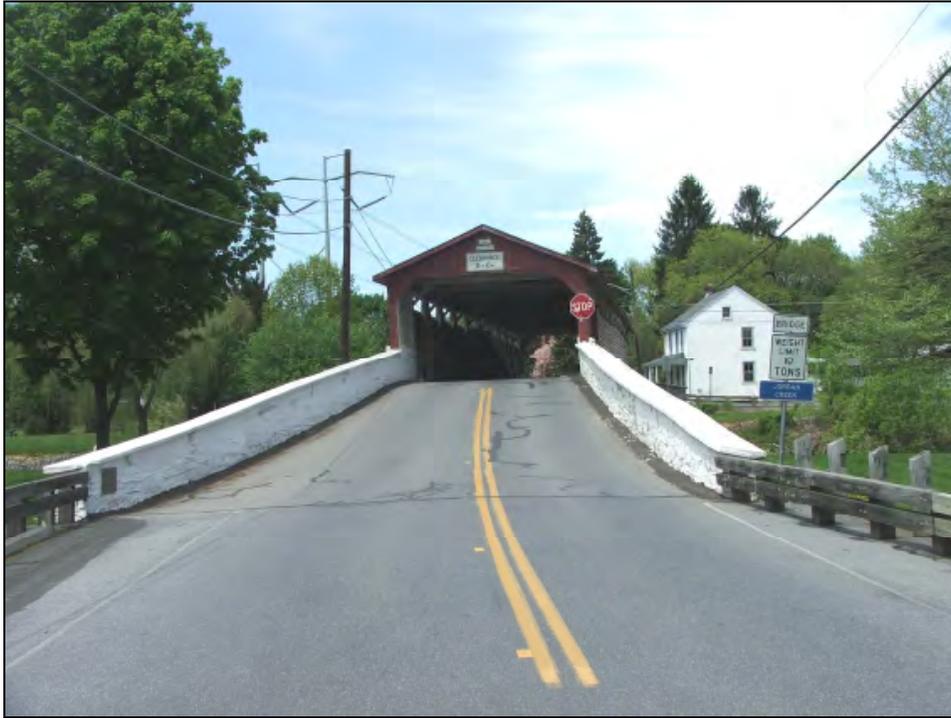
1. The approach roadway, looking from the near side.

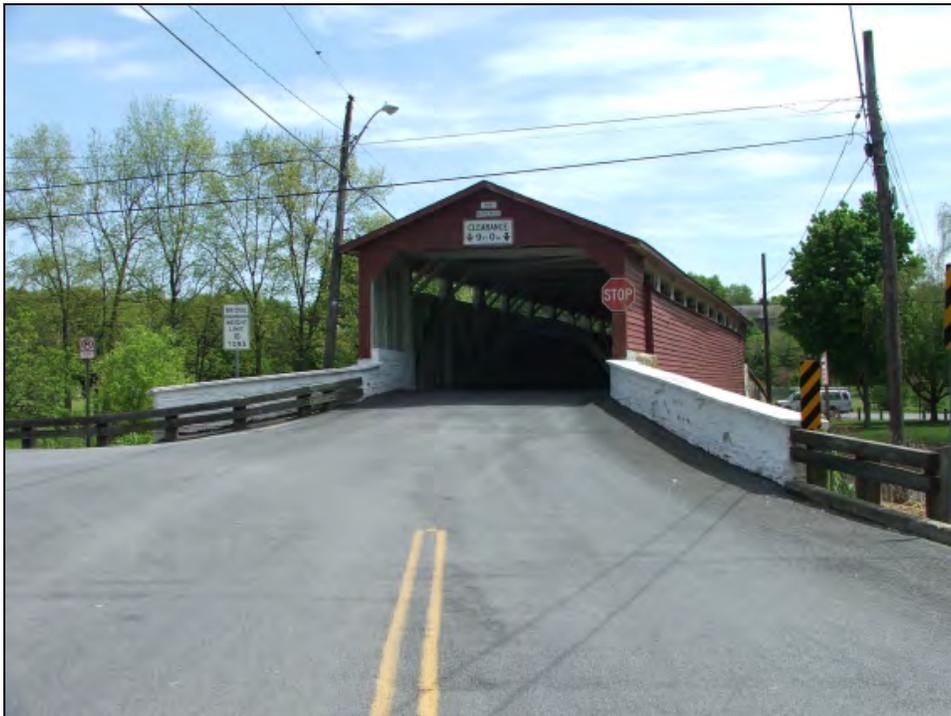
2. The approach roadway, looking from the far side.

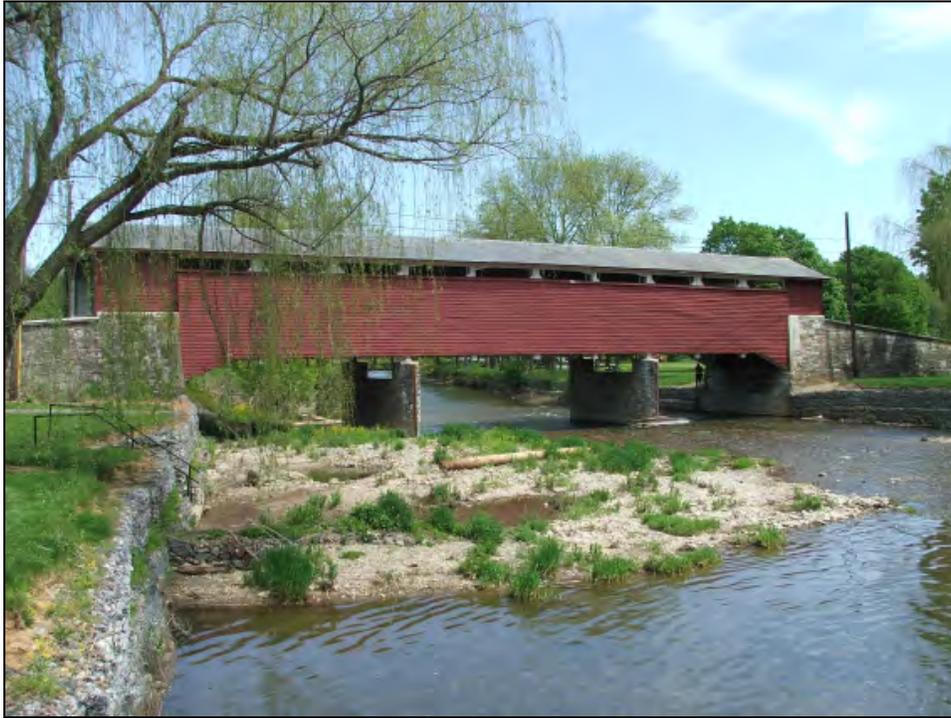
3. Elevation view, looking downstream toward the bridge.

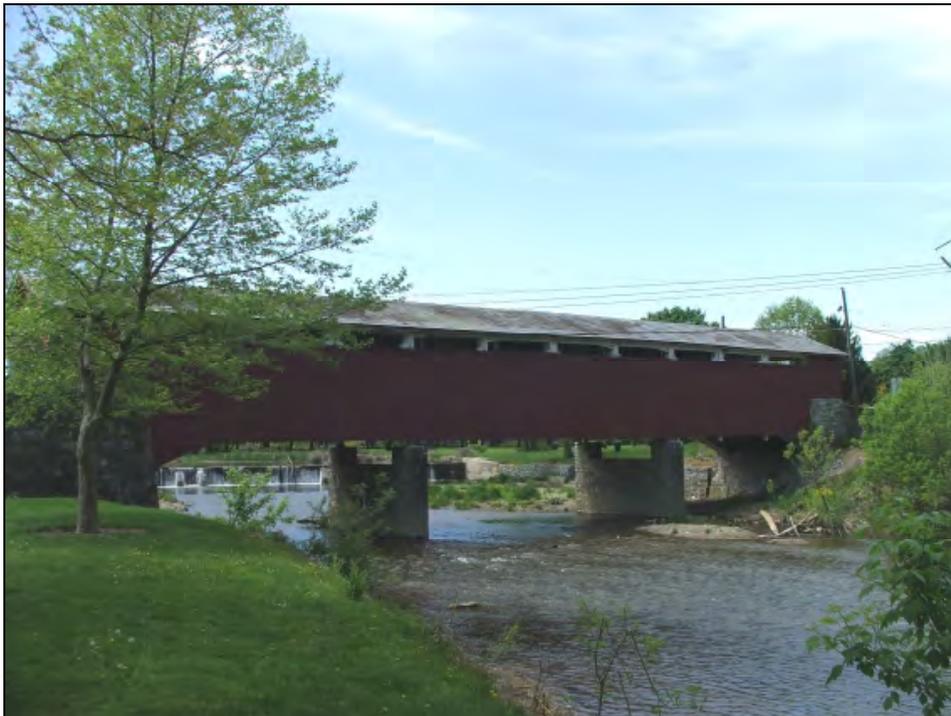
4. Elevation view, looking upstream toward the bridge.

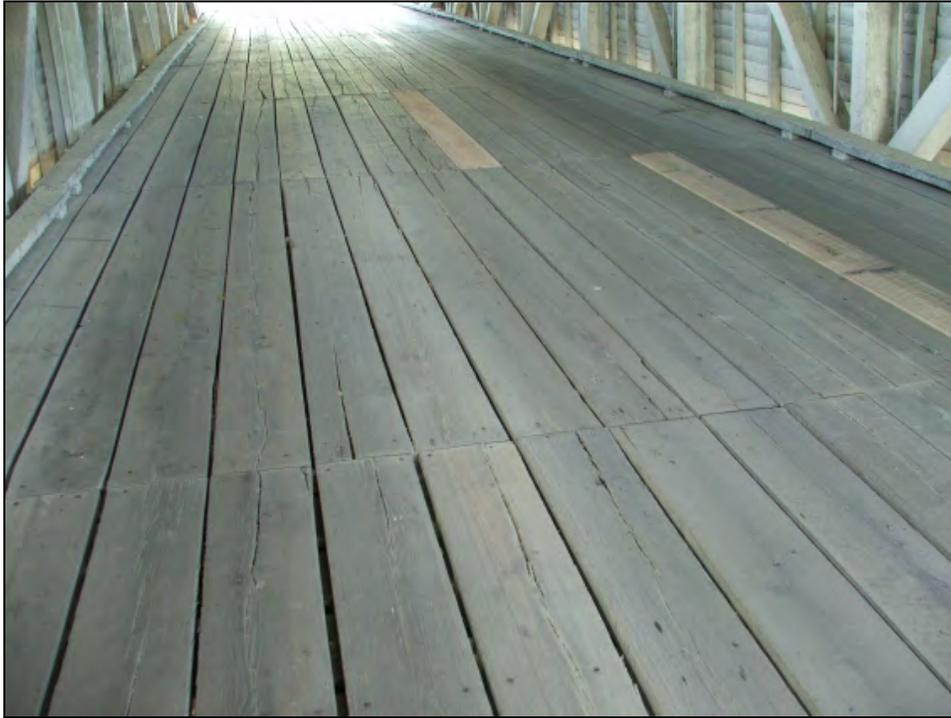
5. View of the top deck surface, looking from the near left.

Deck Top: timber planks (longit.): fairly solid; most planks have longit. checks through the middle (some fairly wide); scattered multiple checks and end splits; few planks toward near end, far end and couple at far end span 1 have light rotting along the checks; There are 8 new planks, need to repalce 38 planks.

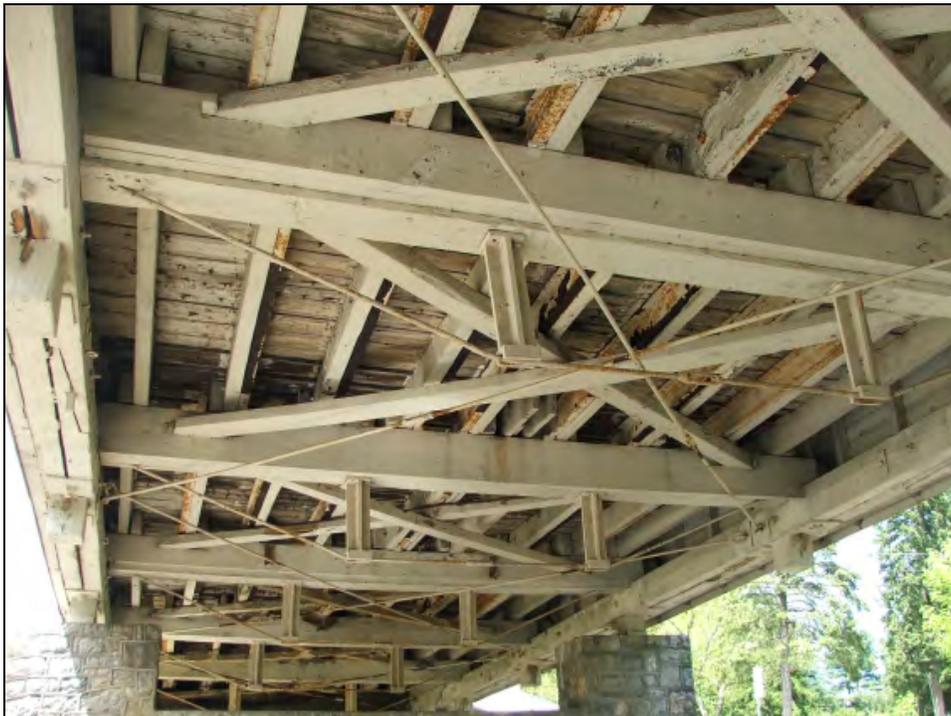
6. View underneath span 2, looking toward the pier 2.

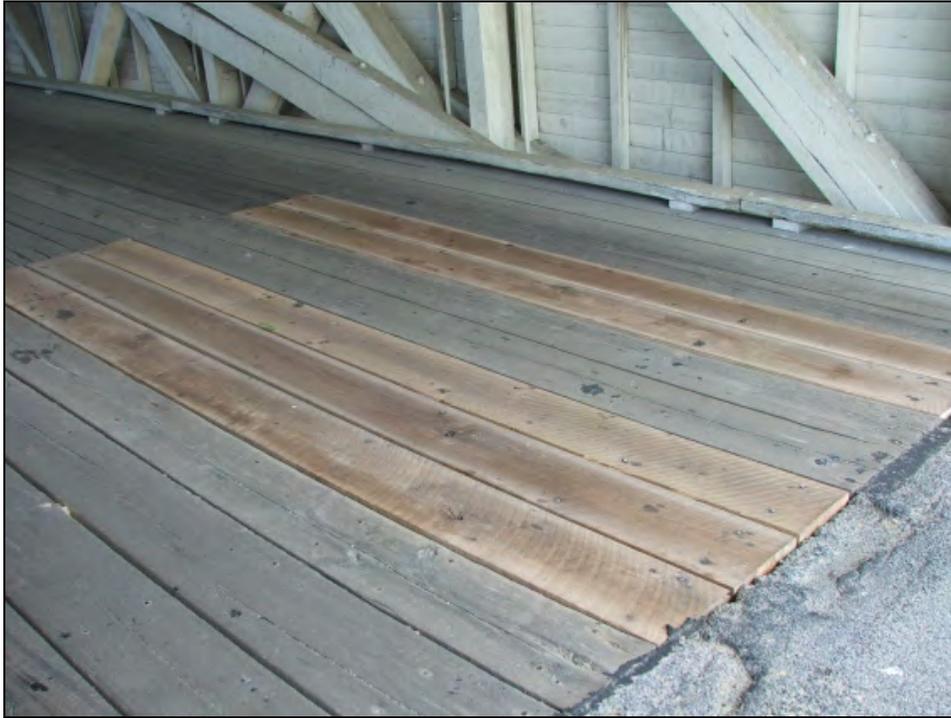
7. View of newer deck planks at the far end.

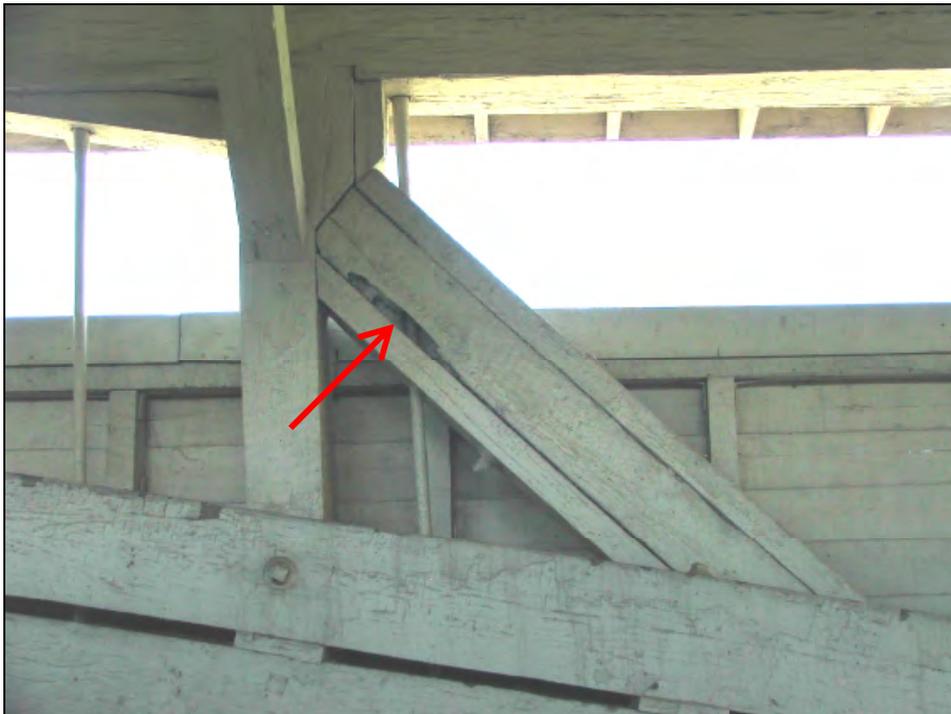
8. View of a void in the right U3, note the strengthening repair.

Truss Members: checking typical thru; diagonals and several verticals stiffened w/planks in end bays; old stable void in original timber (L2-U3 on right); bent vertical steel rod (old damage) to right of vertical #6; small voids (stable) in top left chord (U4-U5); arch has a corner split in bottom chord at far left; arch has several minor scrapes/gouges (painted over); the right truss U6 vertical tie rod is bent; horizontal tie rod in top of bay 7 is bent (slight bend in bay 2 and 4). right truss has a heavy split in outside face from U5-U9.

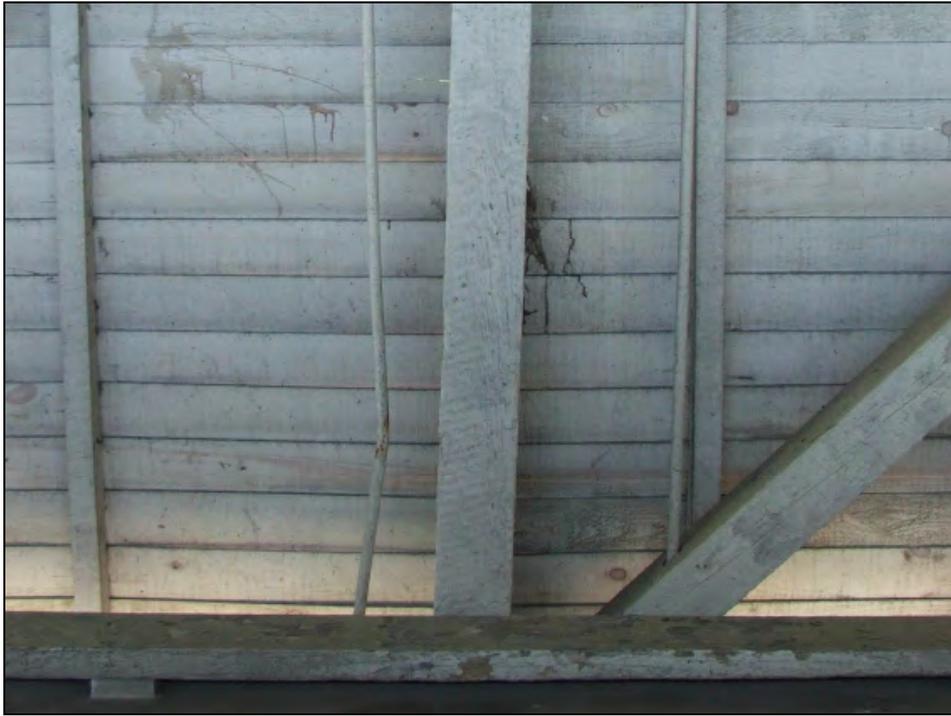
9. View of the bent rod.

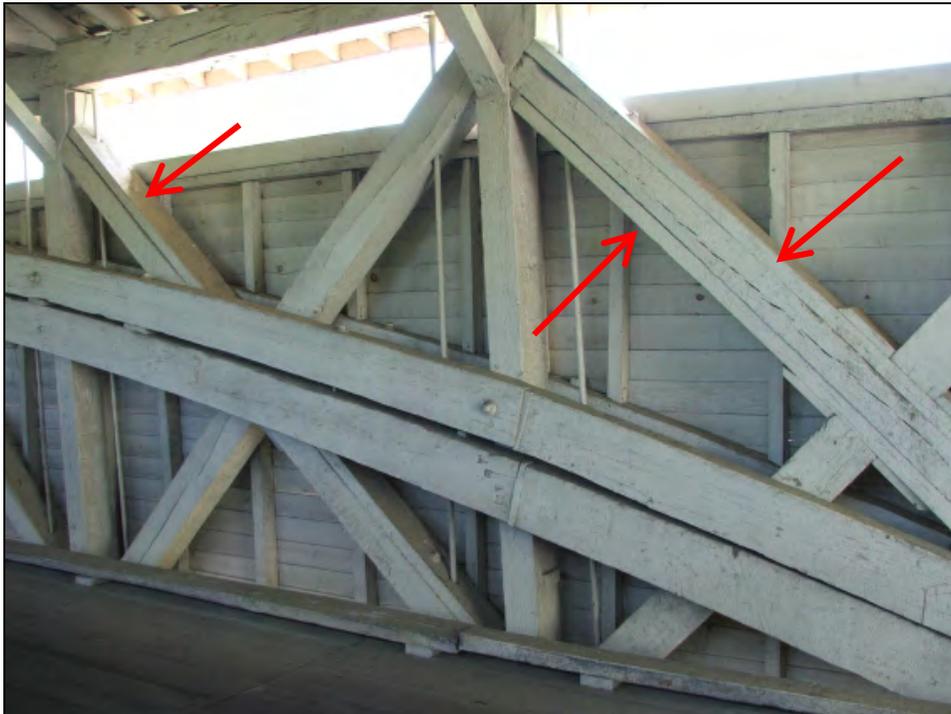
10. View of typical strengthening repairs.

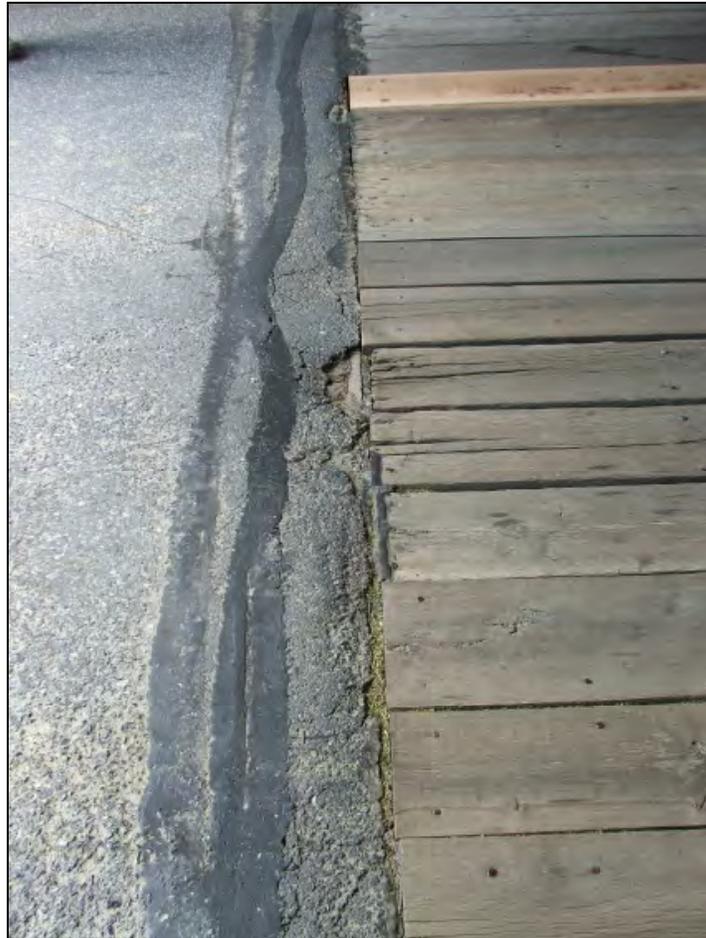
11. Bituminous patch and sealant across near transition.

6B39 Code: 7 - Good
Pavement: Oil/chip at far. Bituminous at near has moderate wear; few random sealed (partially failed) cracks; heavy sealant along masonry walls; pavement over headers at ends of bridge are have a few cracks and shallow spalling; couple cracks sealed
Drainage: None
Shoulders: n/a

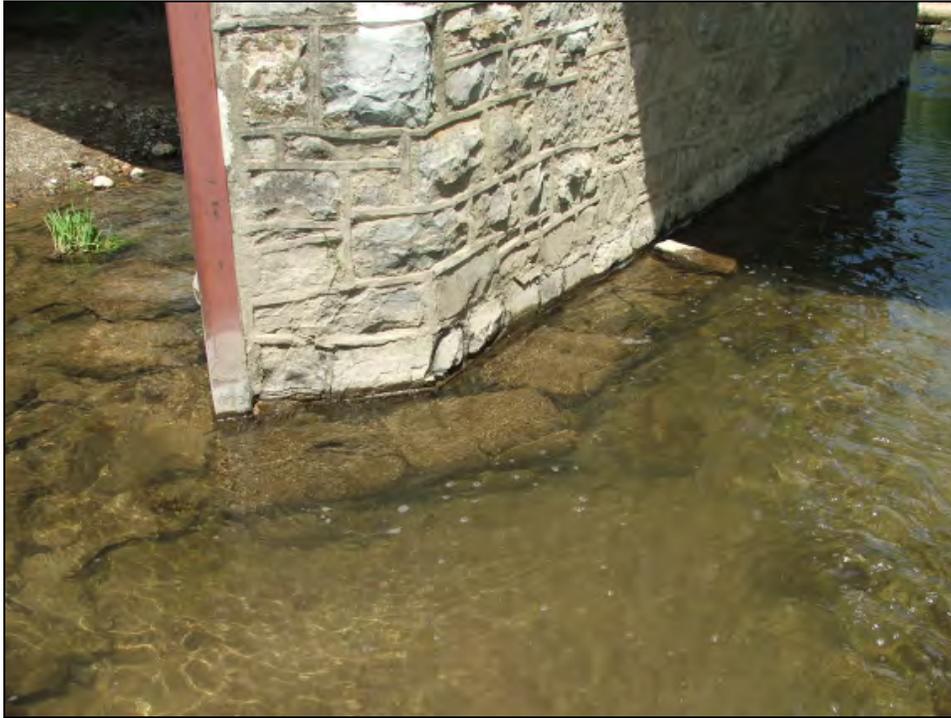
12. View of small grout bags at the upstream nose of pier 2.

Columns/Stems: light mortar deterioration at waterline
grout bags at u/s nose and near left corner are undercut and some have moved;

IN24 Notes: no scour; grout bags around u/s nose are undercut and some have moved; light scour out from pier on near side;

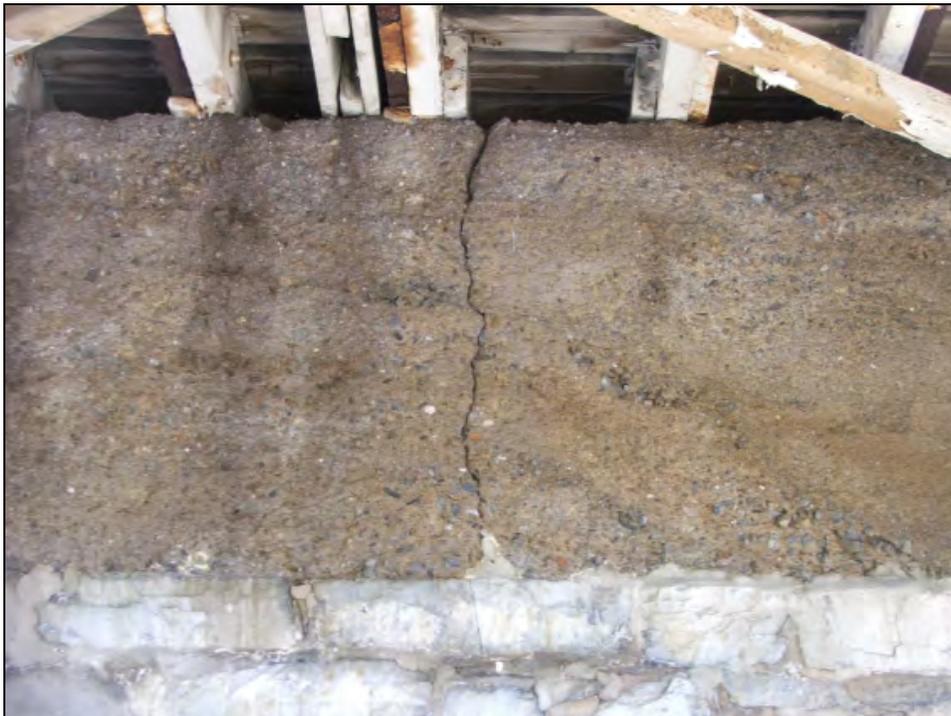
13. Vertical crack in the concrete across the top of the near abutment.

Bridge Seats: rough/honeycombed conc w/ wide vert stable 1/8" to 1/4" open crack at middle

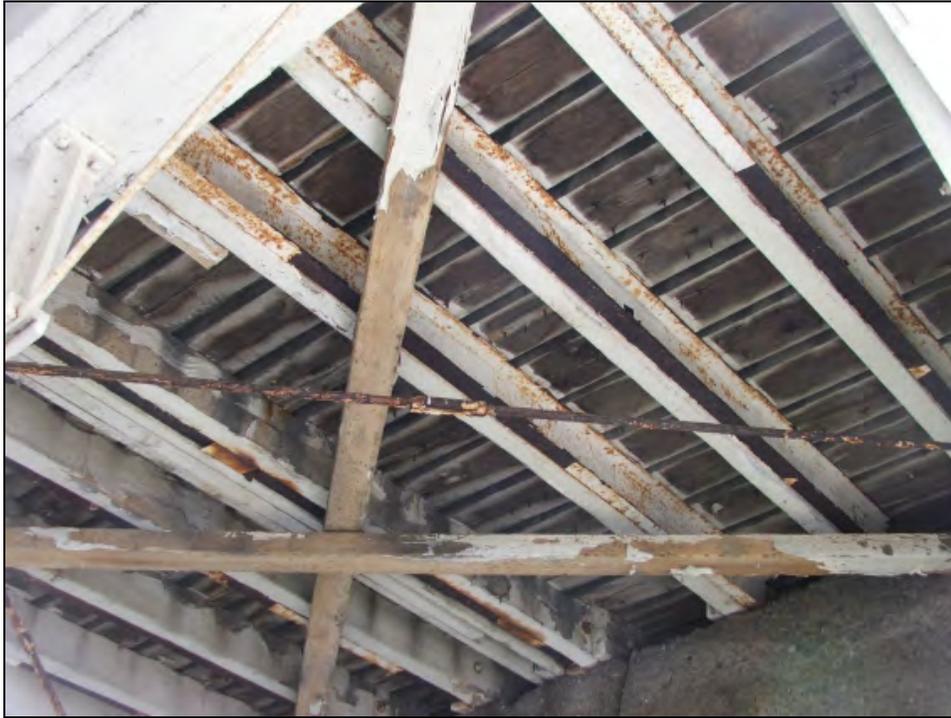
14. Typical view of stiffened stringers with steel channel.

Stringers: timber stringers w/steel channel strengthening; timber has light checking;
 steel channels have pitting; numerous have rust and minor loss across bottom flanges; rust extends into web in span #3 where flange loss is more moderate;
 original timbers are rotted away at far abutment and the channels are too short to bear on seat; the old timber stringers were lengthened w/retrofitted timber that cantilevers to the abutment and bearings. Need at least 1 additional bolt to make stable.

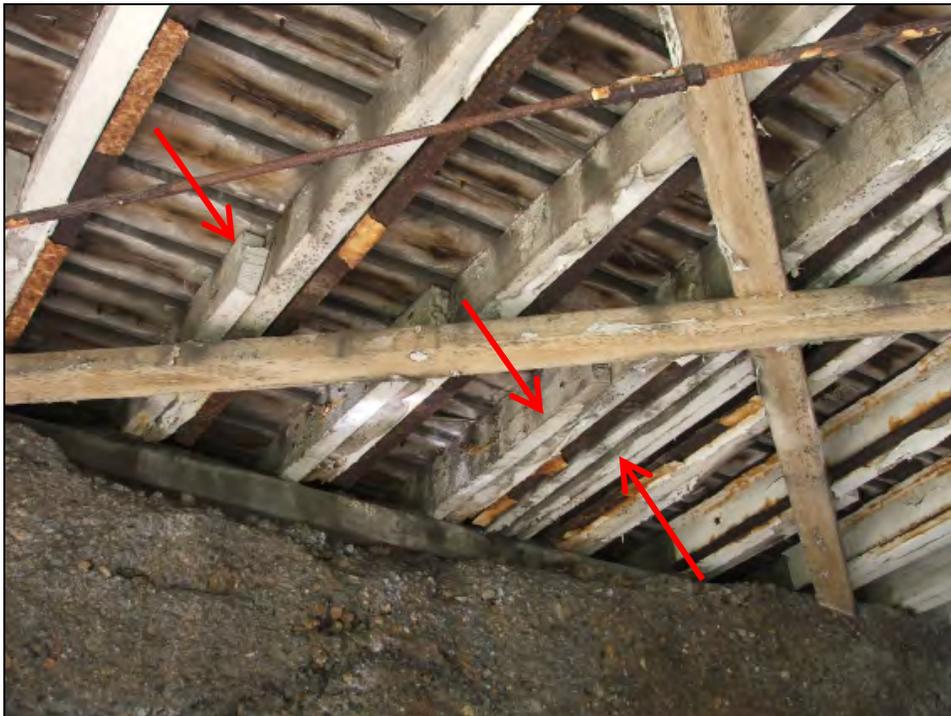
15. View of the typical stringers at the far abutment.

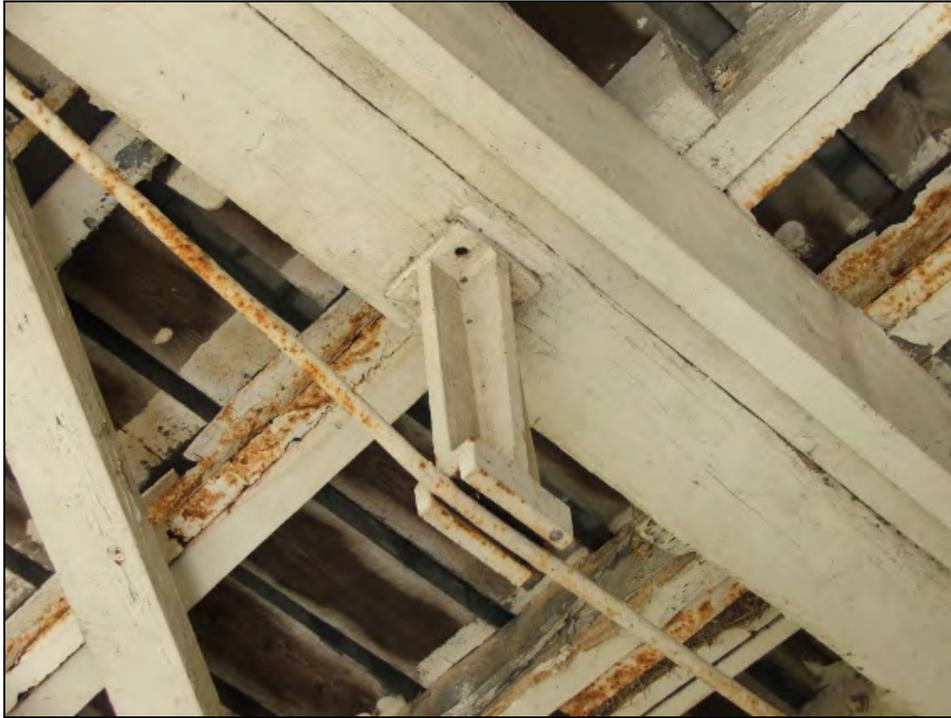
16. Loose king post (missing and loose bolts) on the left side of FB #3 in span 2.

Floorbeams: Notched timber floorbeams with plank strengthening w/timber planks; floorbeams are checked w/some fairly wide;
 FB #5 king post is missing 2 bolts & 2 are loose on left;
 FB #6 king post is missing 1 bolt on left.
 all floorbeams have steel rod and bottom offset (king posts) strengthening

IM09	Location 1,3						
Flexible	60 - B744601-RPR/RPL.TMBR.MBR	2	EA	2	05/19/2010	0	No
IM07	Status: 0 - Work not planned		IM15	Notes: Repair the floorbeam king posts.			
IM09	Location 12

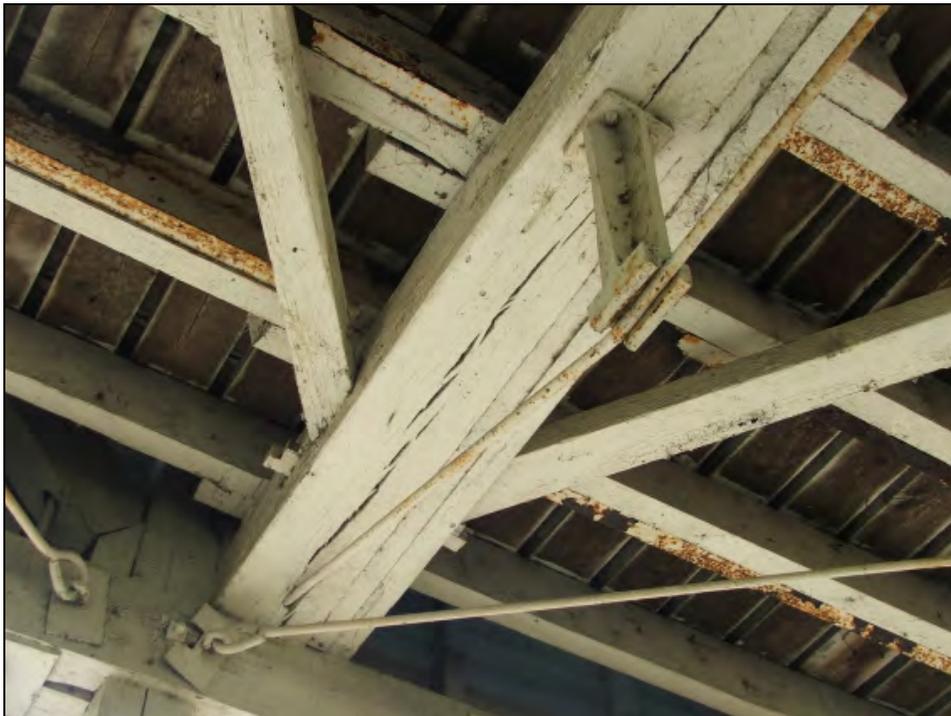
17. View of the floor beam 2 in span 1 with wide checking.

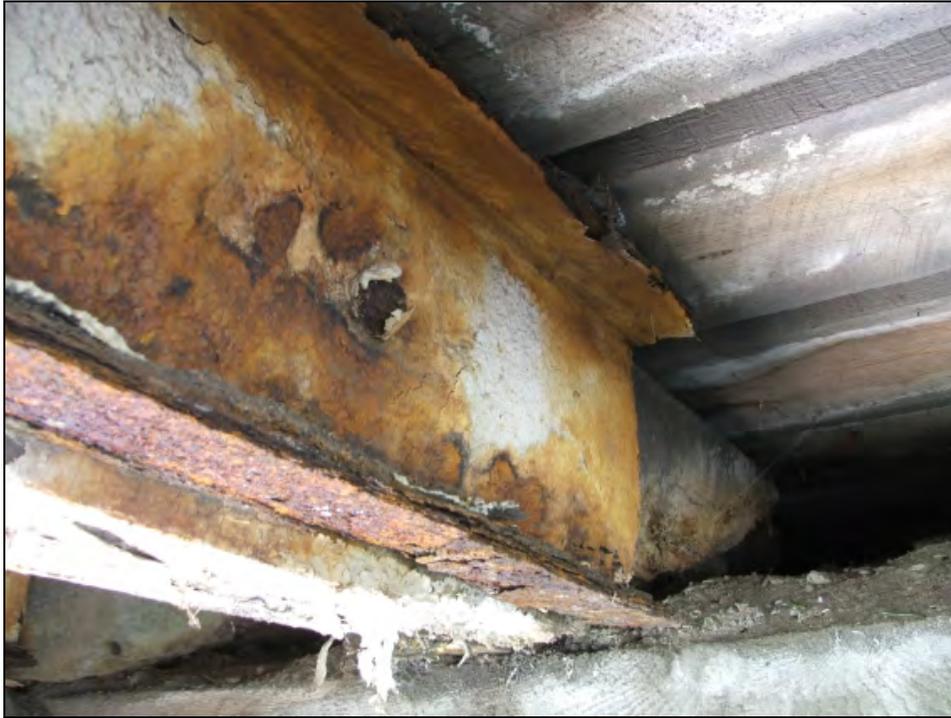
18. View looking at the far end of stringer 3.

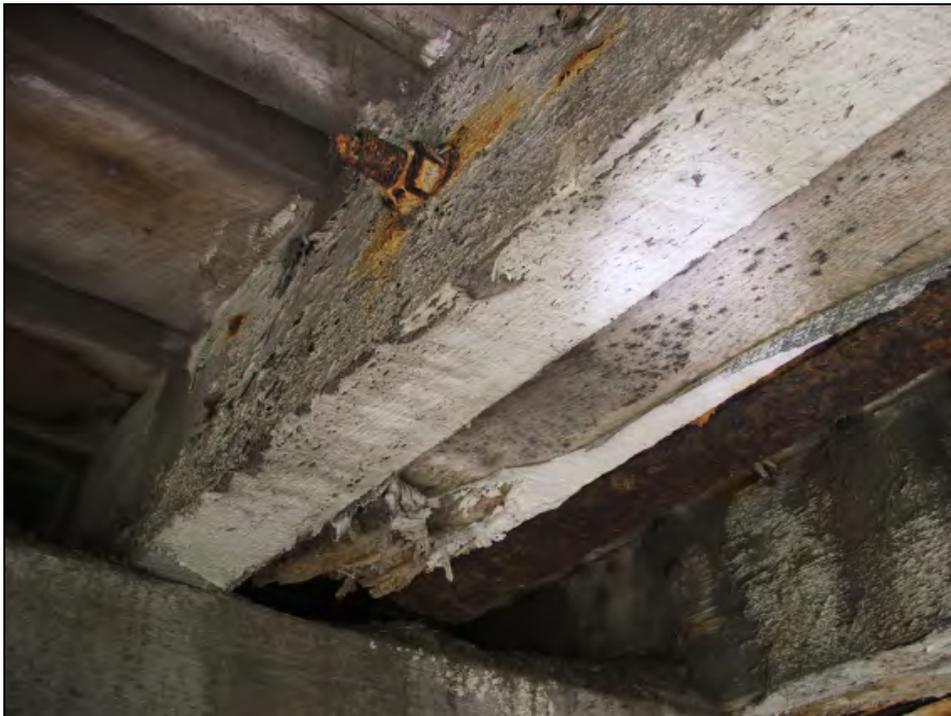
19. At the far abutment, extra timber planks cantilever from the original rotten stringers, seen here at stringer #4.
