LEHIGH COUNTY BRIDGE NO. 13
LOCATION: LOWHILL TOWNSHIP
RUHETOWN BRIDGE
JORDAN ROAD OVER JORDAN CREEK
CUSTODIAN: LEHIGH COUNTY

BMS NO. 39720505939013

DATE OF INSPECTION: DECEMBER 22, 2011
INSPECTOR: BRENT MILLER
DAVE ZIEGLER

Confidential - Structure Safety Inspection Study

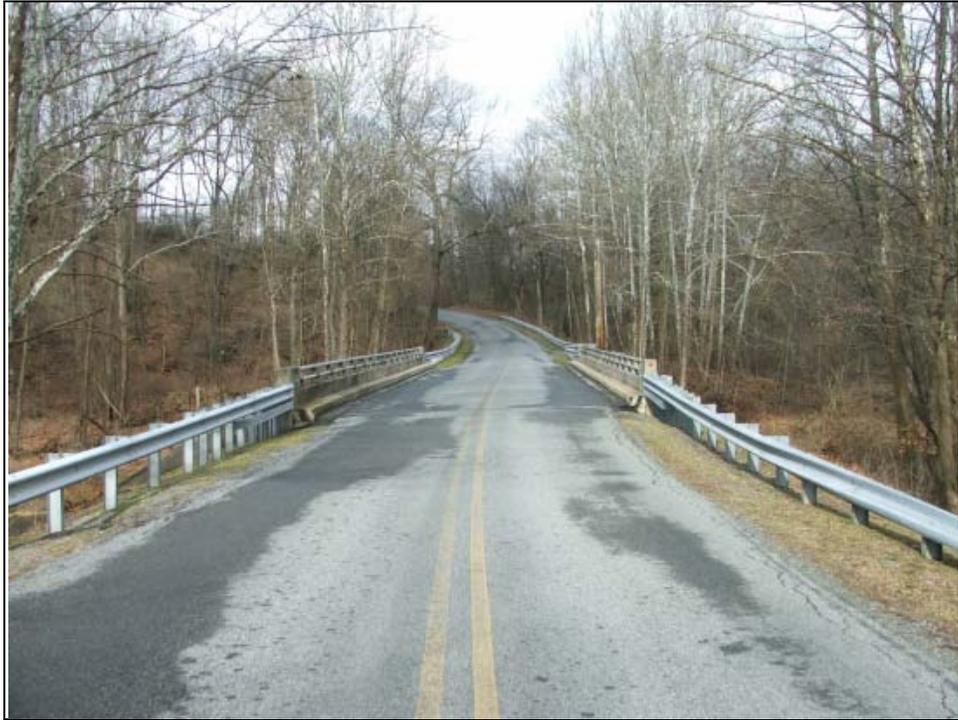
The oil/chipped bituminous pavement is lightly worn, with minor edge cracking observed. A little erosion was noted at the far left corner. One displaced post each at the near right and near left guiderail has no affect on the strength of the rail.

1. The approach roadway, looking from the near side.

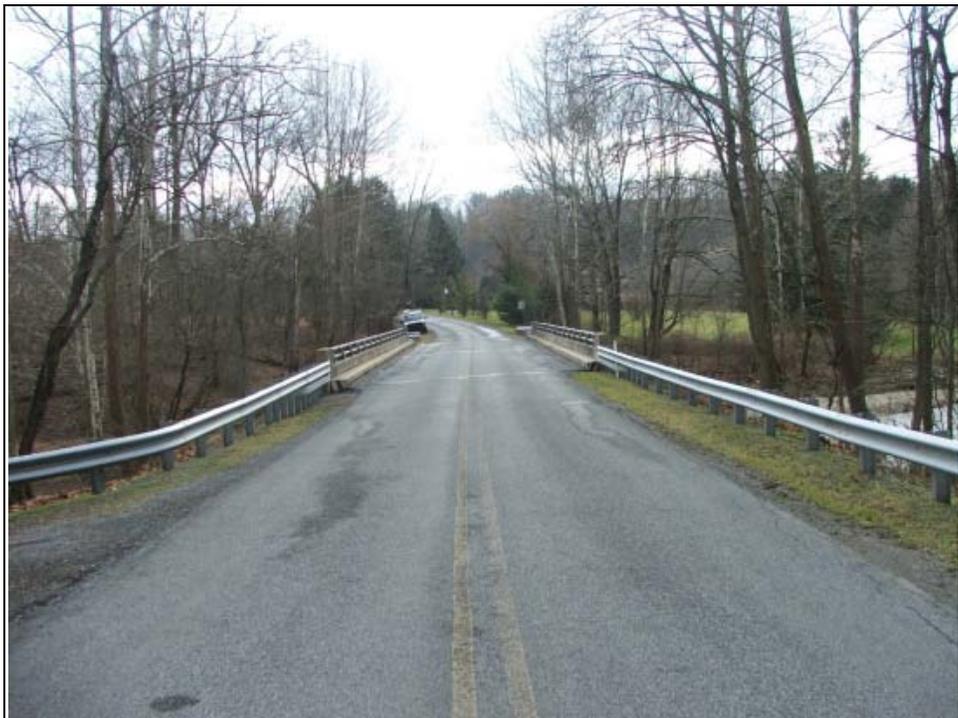
2. The approach roadway, looking from the far side.

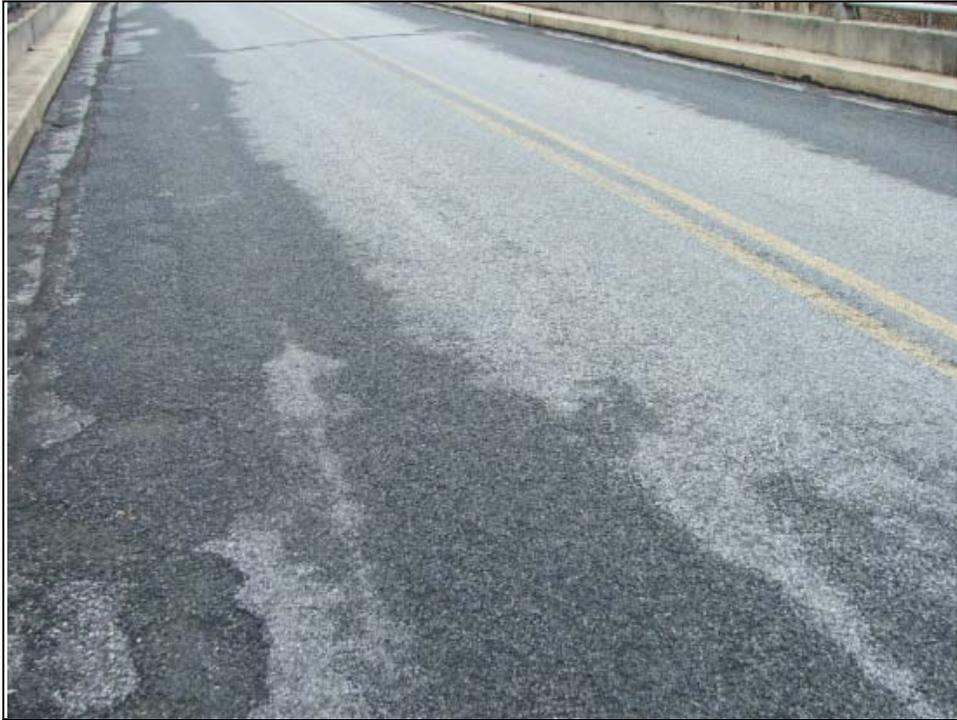
The oil/chipped bituminous surface is lightly worn and has several recently sealed cracks. On the bottom drainage stains, efflorescence and some rust stains were noted along the beam joints.

5. View of the top deck surface, looking from the near left.

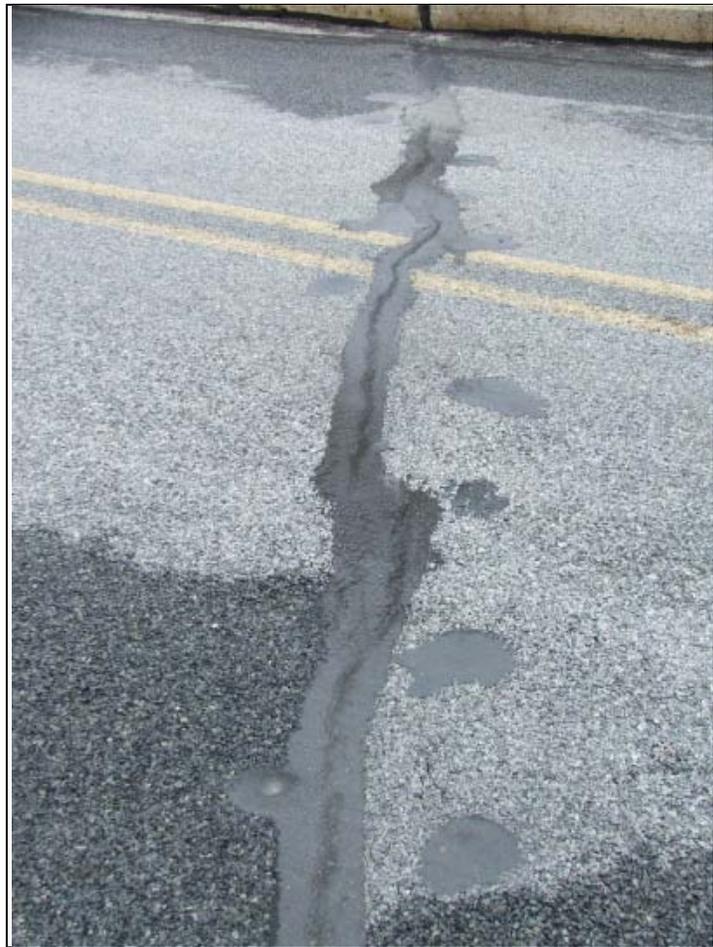
A few vertical shrinkage cracks and other light hairline cracking were observed at the abutments and pier. The far abutment stem has a small spall at the top left, while the far right wing has several tiny delaminations/cover spalls. There is also some very light scour at the far right corner. The upstream nose of the pier has a couple small delaminations toward the top and some debris (say 3 cy) and scour.

7. Sealed crack and spalls across the pier.

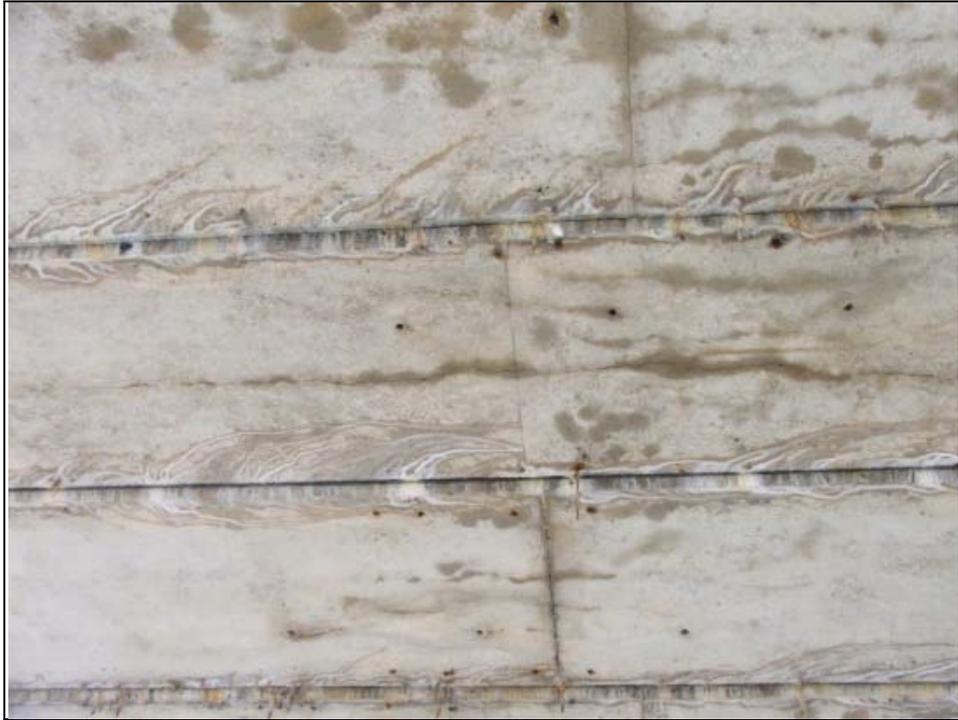
Variable length, non-continuous, hairline longitudinal cracks are typical across the bottom flanges of the beams. A couple cracks are as wide as 0.035", with some minor rust stains noted. Rust and stains were also noted at a few of the weep holes. The grouted transverse tendon pockets are lightly cracked, with a couple spalls and delaminations noted.

8. Typical view of longitudinal cracks and beam joint stains/efflorescence in span 1.

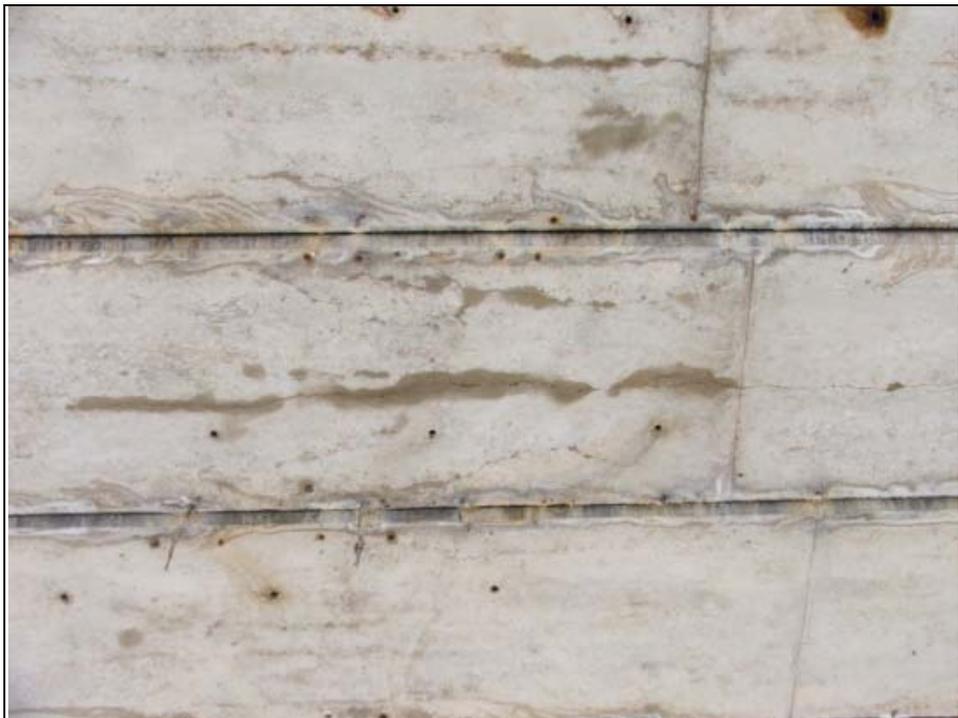
9. Typical view of cracks in span 2.

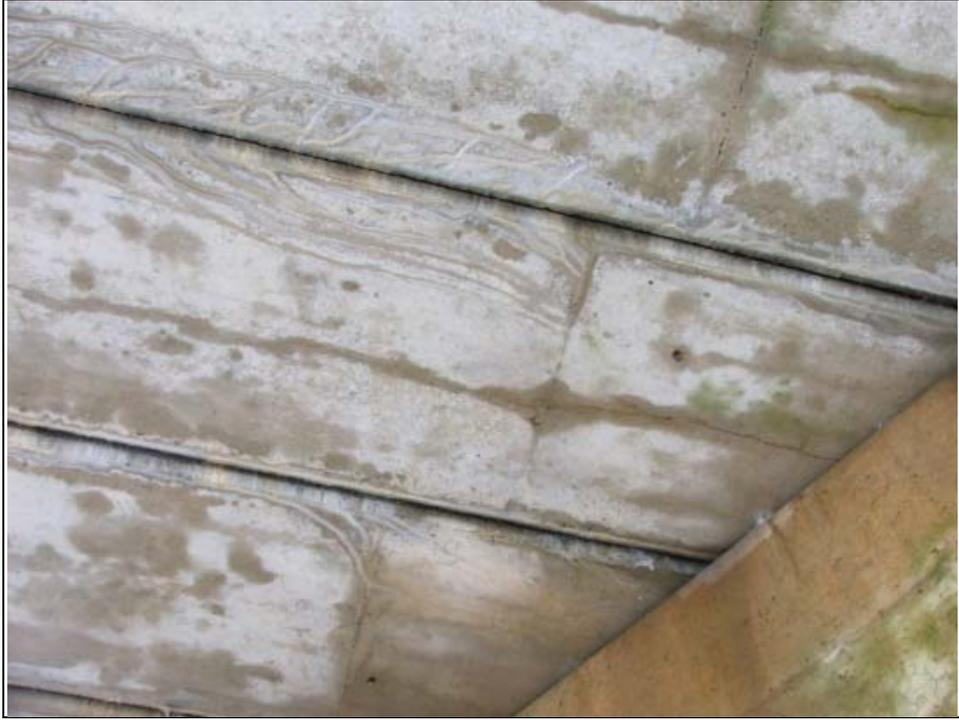
10. View of crack and moisture at the near end of B6 in span 1.

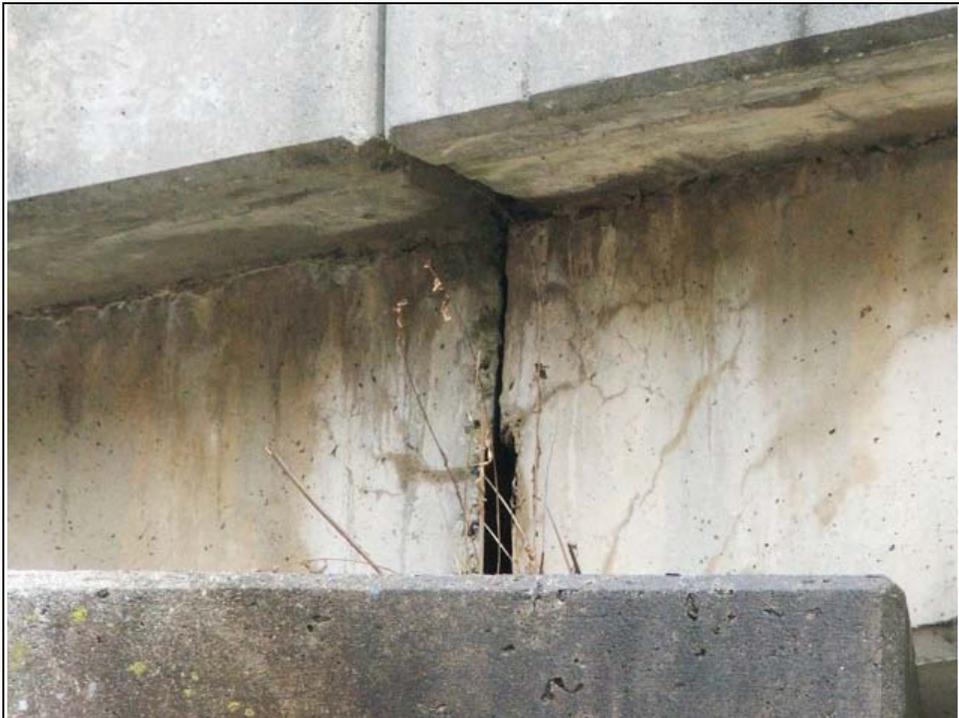
11. Fascia beam web cracking over the pier.

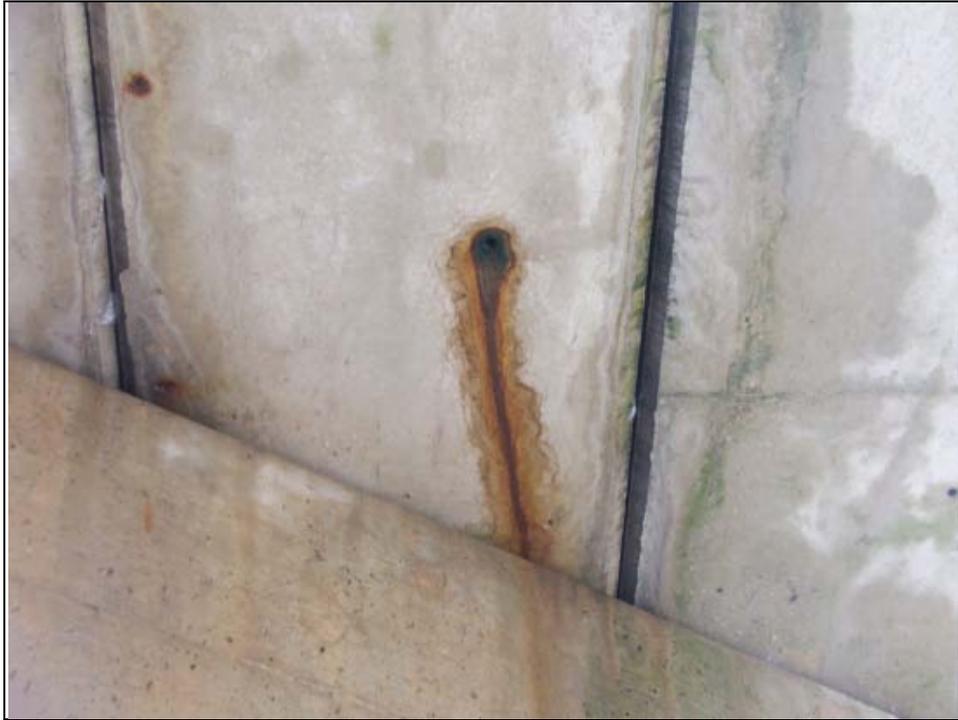
12. Rusty drainage coming from the near weep hole of B2 in span 1.

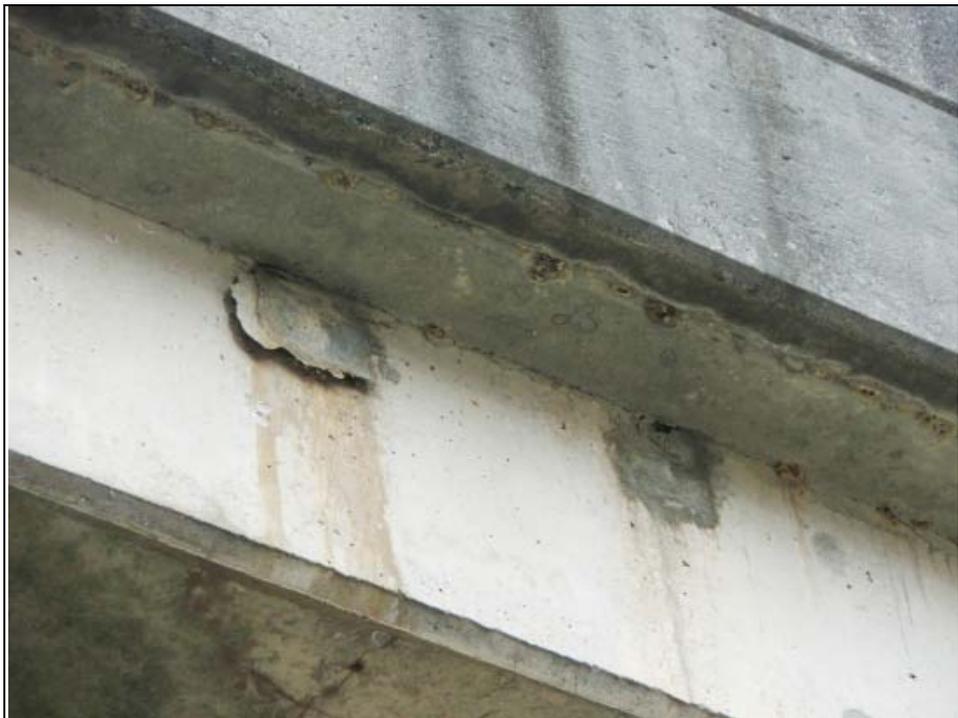
13. Delaminated grout at the span 2, far right fascia beam transverse tendon pocket.

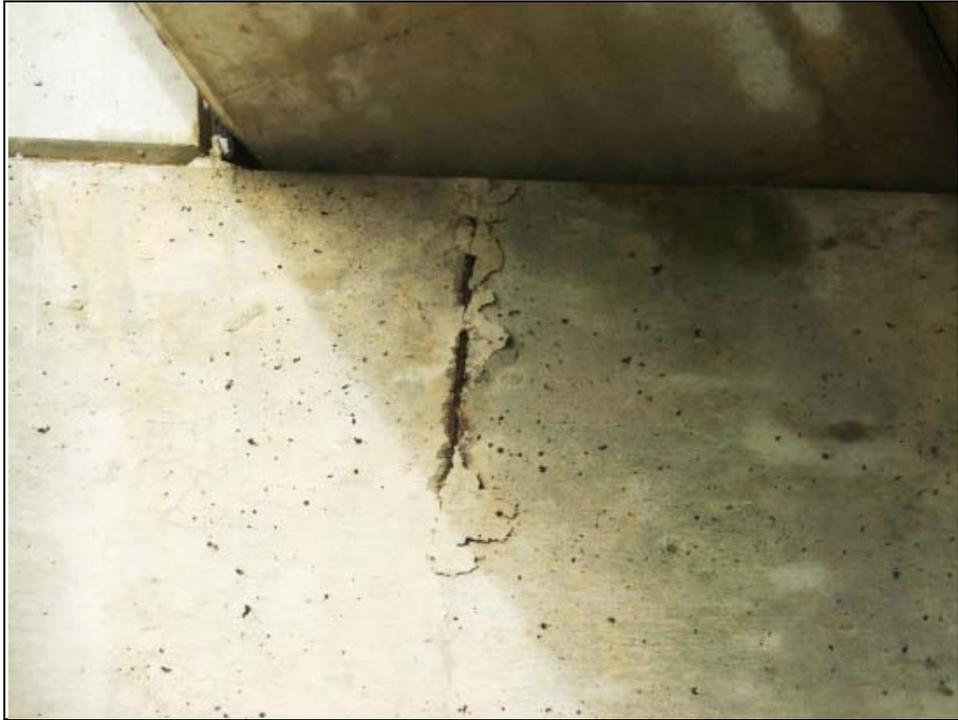
14. Cover spall at the top of the far left stem.

1. Replace/update the bridge barrier to meet current standards. (\$25,000)
2. Remove debris and place rock protection around the upstream pier nose. Consider removing the deposit downstream from span 1 to improve the flow through the bridge. All work in the channel requires a permit from the DEP. (\$8,000)
3. Monitor the cracking in the bottom of the beams, and consider a superstructure replacement if conditions worsen.
4. Repair the spalled areas at the far abutment and wings.

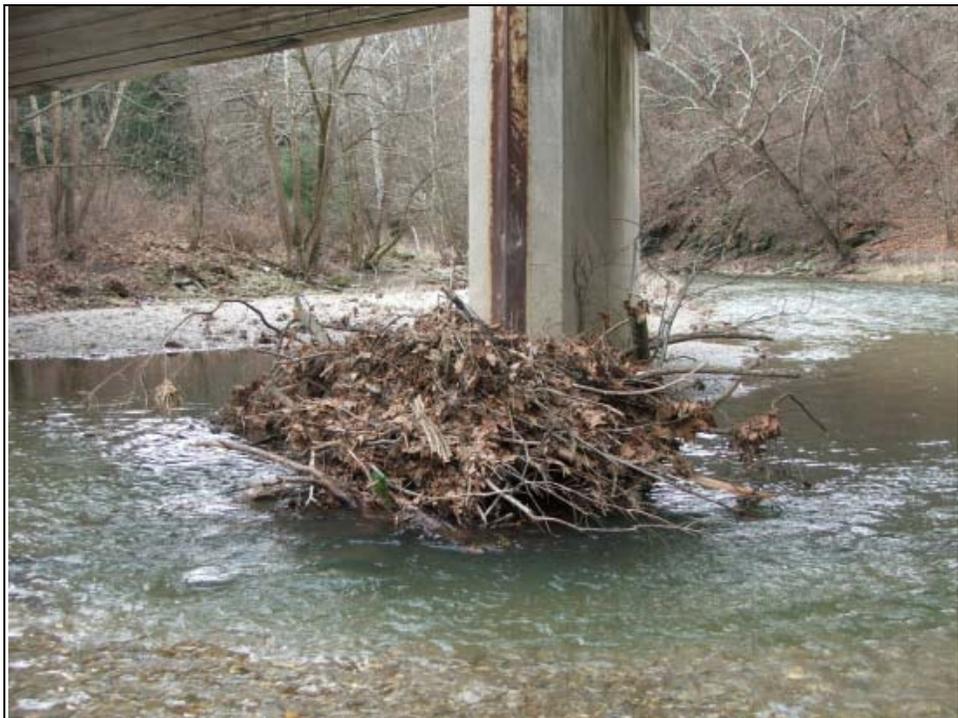
The creek is well aligned toward the pier and span 2. There is some flow into, but not out of, span 1, with a deposit extending about 150' downstream from span 1. As noted above, there is some accumulated debris on the pier nose.

15. Debris and scour at the upstream nose of the pier.
