LEHIGH COUNTY BRIDGE NO. 29  
LOCATION: CITY OF ALLENTOWN  
BASIN STREET OVER LITTLE LEHIGH CREEK  
CUSTODIAN: LEHIGH COUNTY

BMS NO. 39730100009029

DATE OF INSPECTION: DECEMBER 1, 2011  
INSPECTOR: BRENT MILLER  
SCOTT KLINE

**Confidential - Structure Safety Inspection Study**

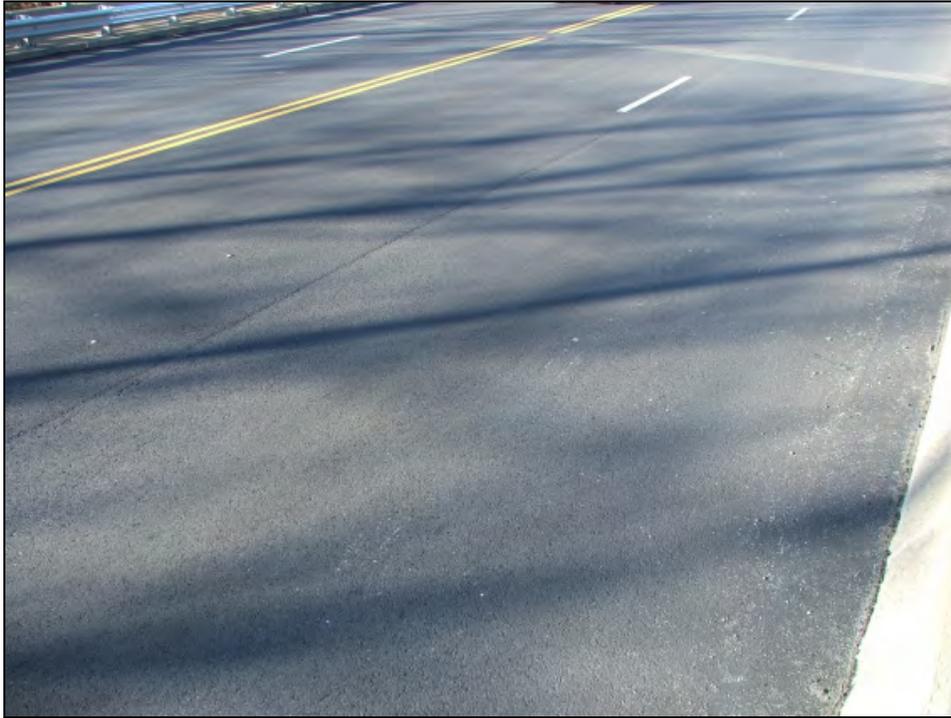
5. View of the top deck surface, looking from the near right.

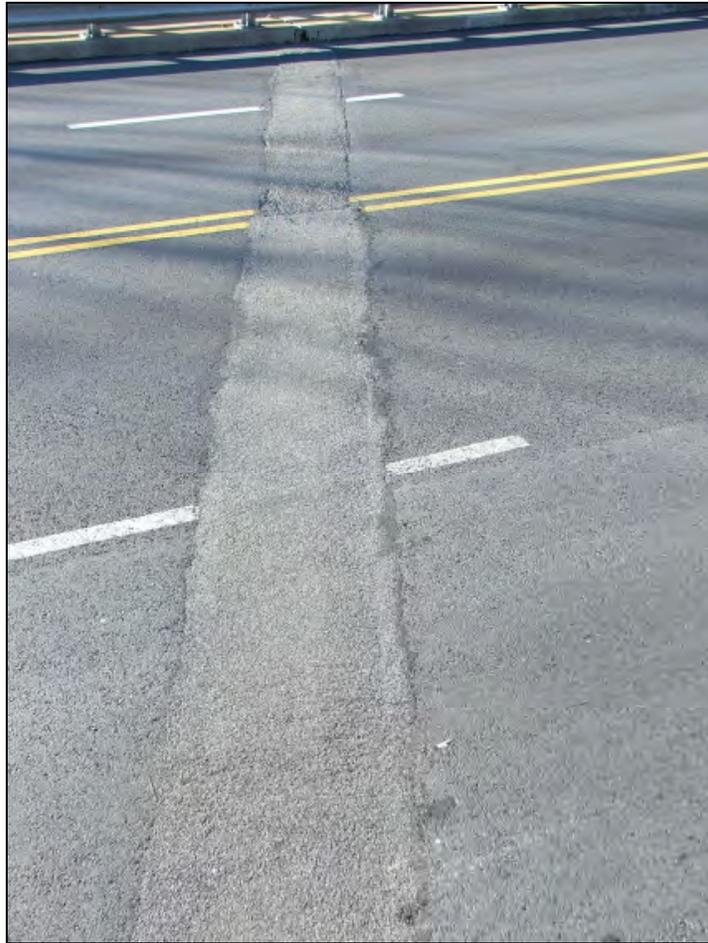
7. Typical asphaltic plug pier joint replacement.

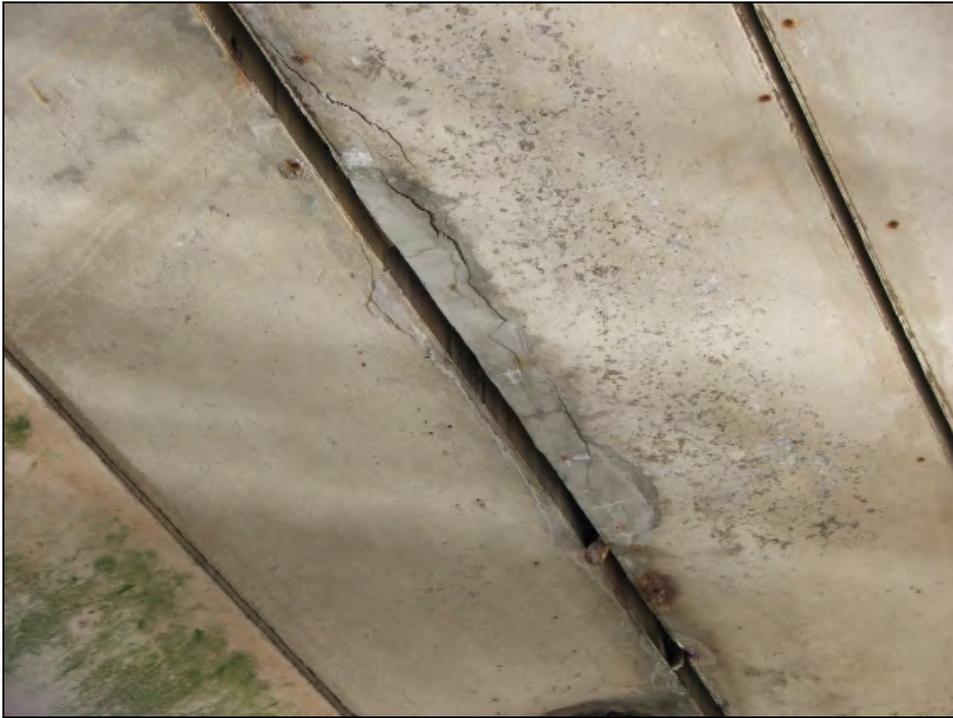
8. One of two cracked/delaminated patches (previously 1 strand) at B3 in span 1.

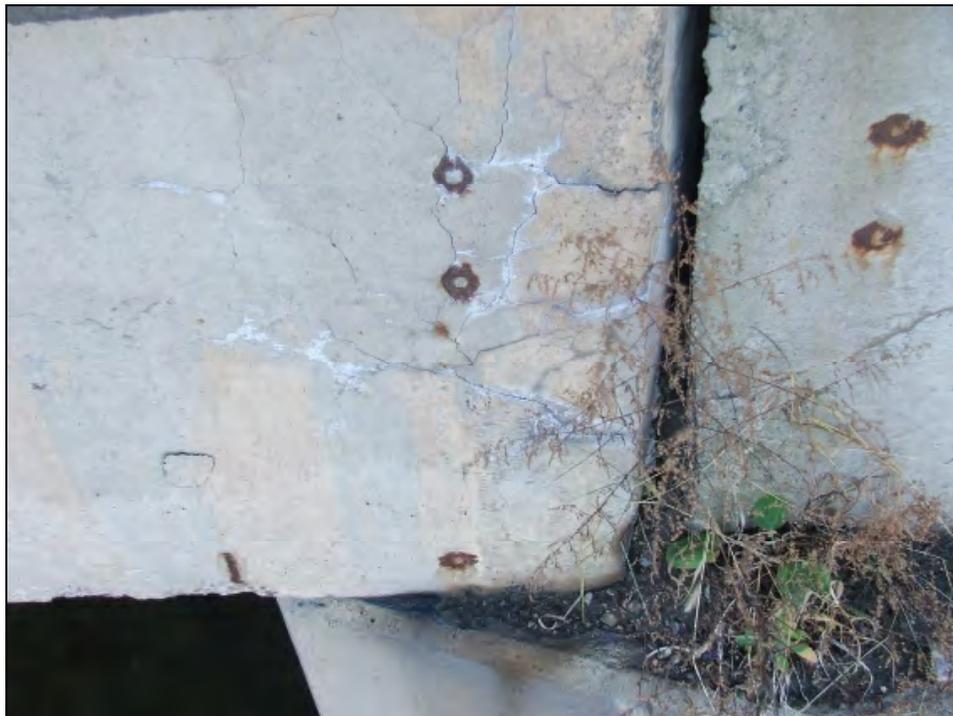
9. Web cracking at the pier end of the span 1, right fascia beam.

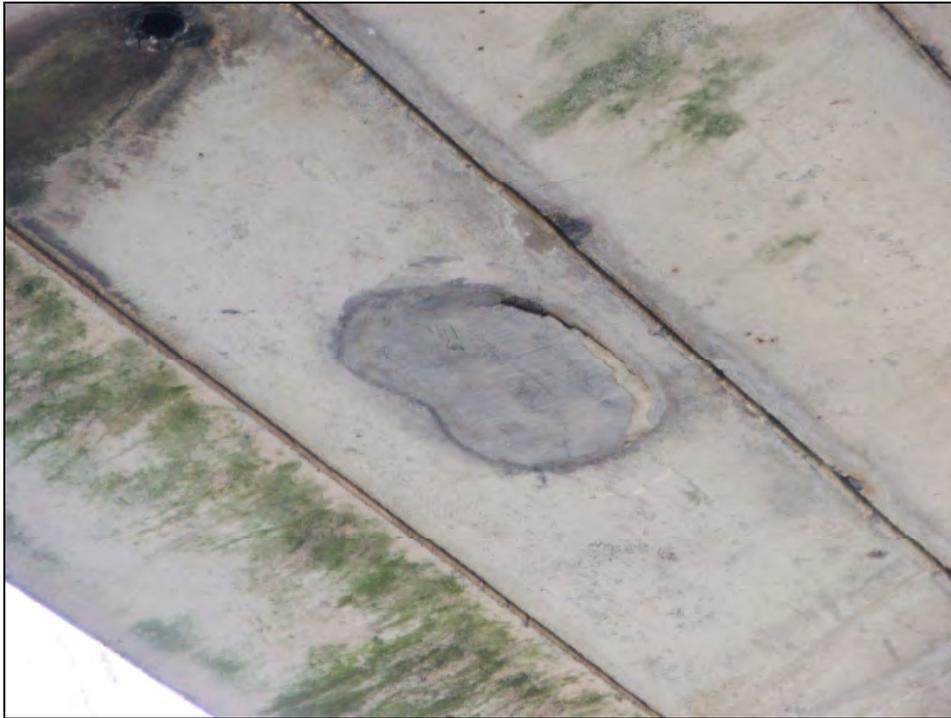
10. Lightly cracked and spalling patch (previously 3 strands) at midspan B2 in span 2.

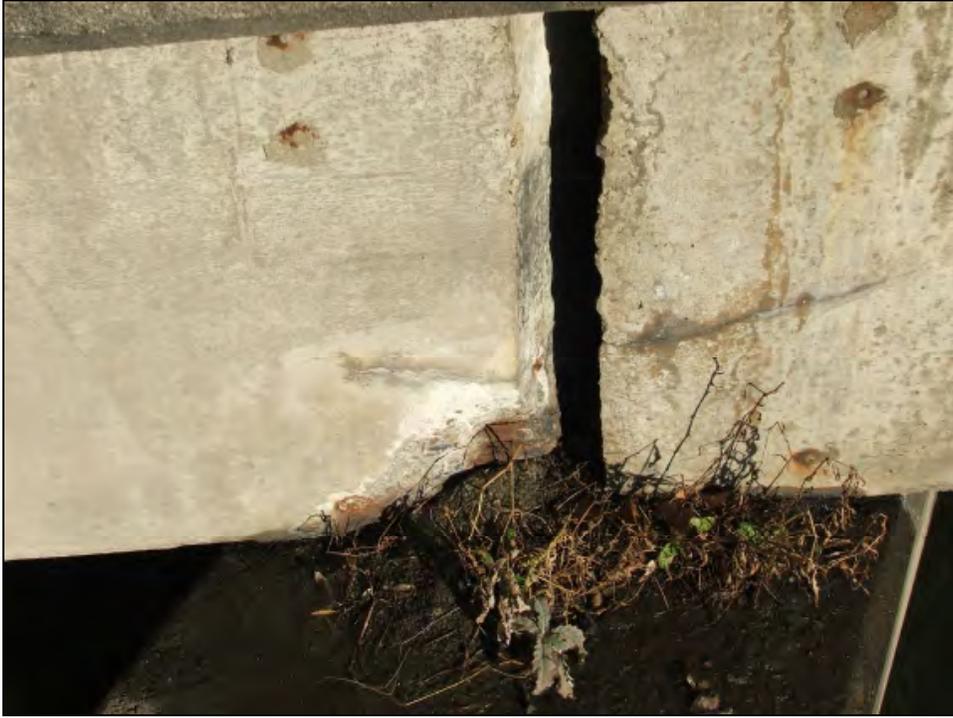
11. Spall with two visible strands at the pier end of the span 3, left fascia beam.

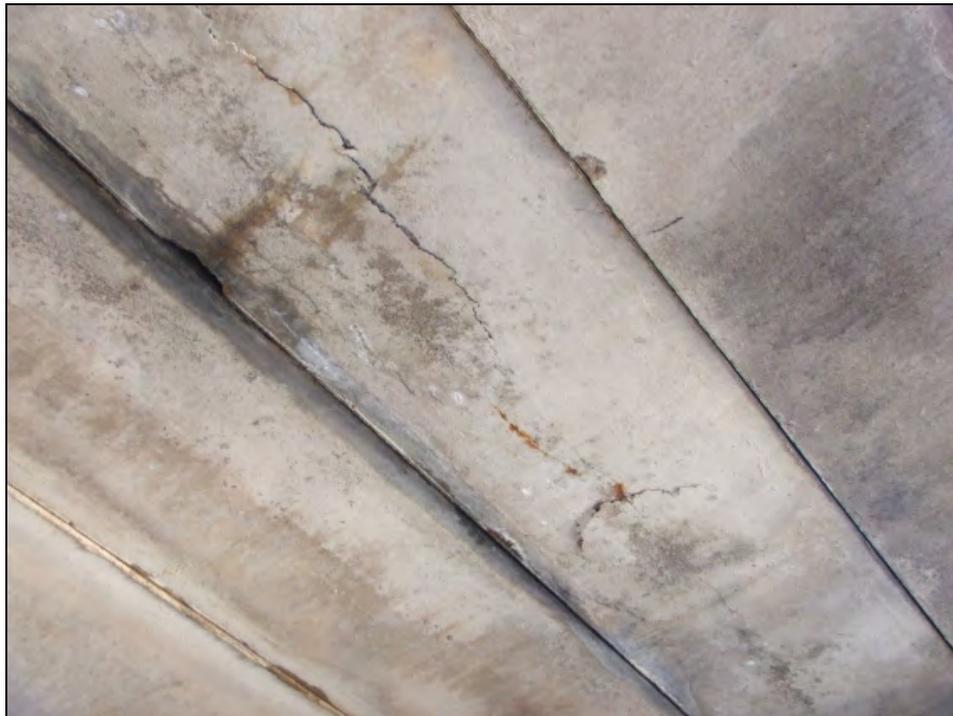
12. Cracks/delamination across the bottom of B2 in span 3.

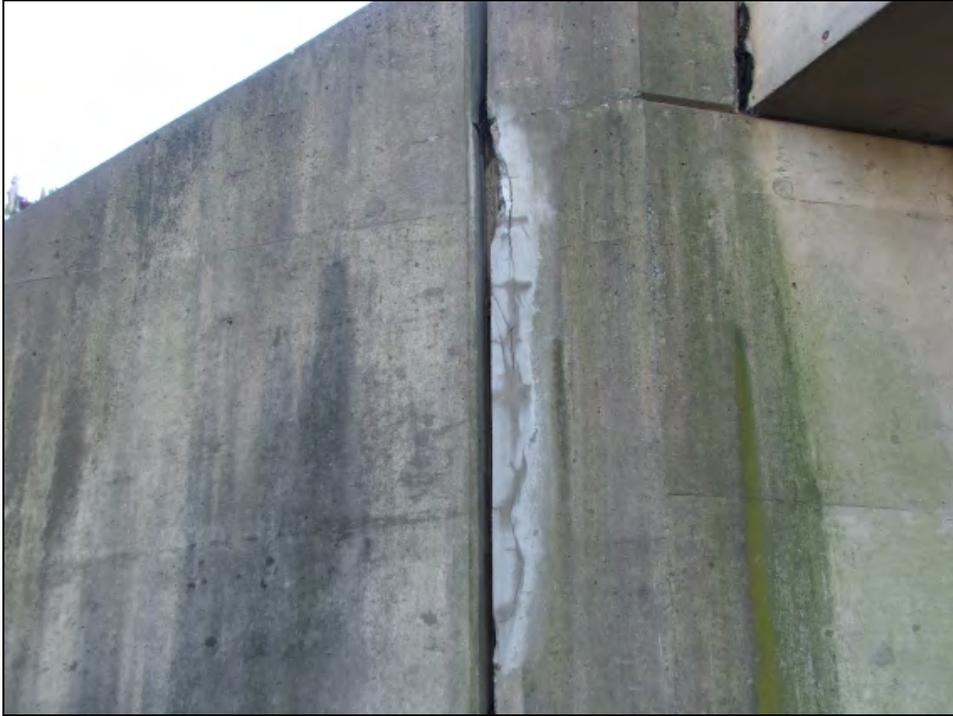
13. Cracked and spalling patch at the near right stem corner.

**Stem:** 3' x 1' spall @ bottom left;  
lightly cracked patch @ top right (@ utility);  
cracked patch @ top half of joint w/ right wing - spalling of patch @ top

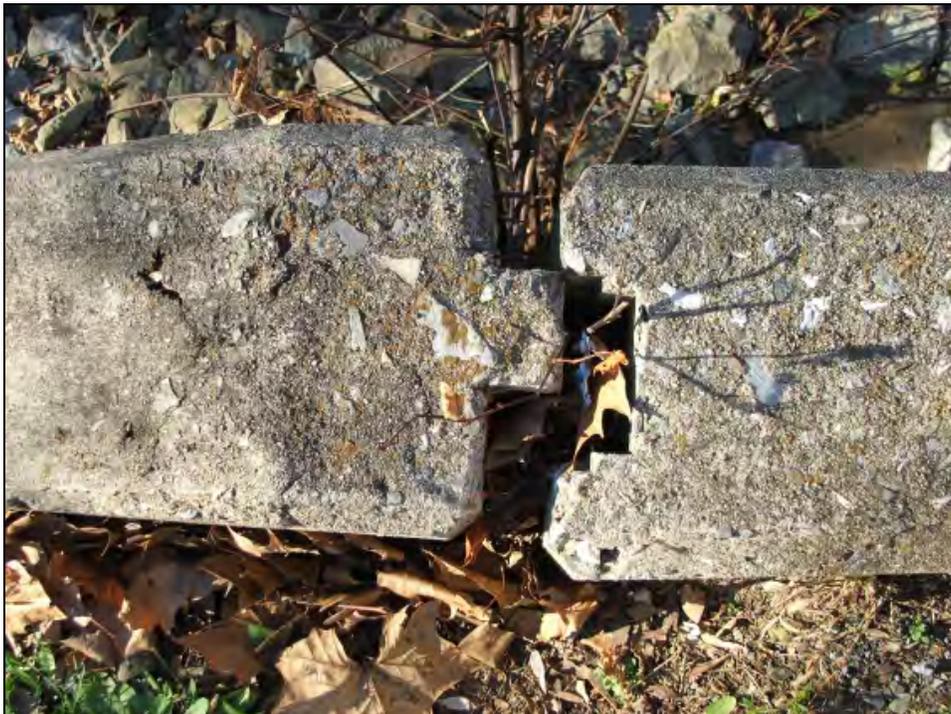
14. Approximate 2" gap at the near left stem/wingwall joint is unchanged.

**Wings:** 2" gap measured @ top of each wing joint;  
some erosion @ free end of extended left wing from tributary flow

1. This bridge should be inspected by a qualified bridge inspector or engineer a minimum of once every two years.
2. Continue to monitor the gaps at the near abutment wingwall/stem joints.

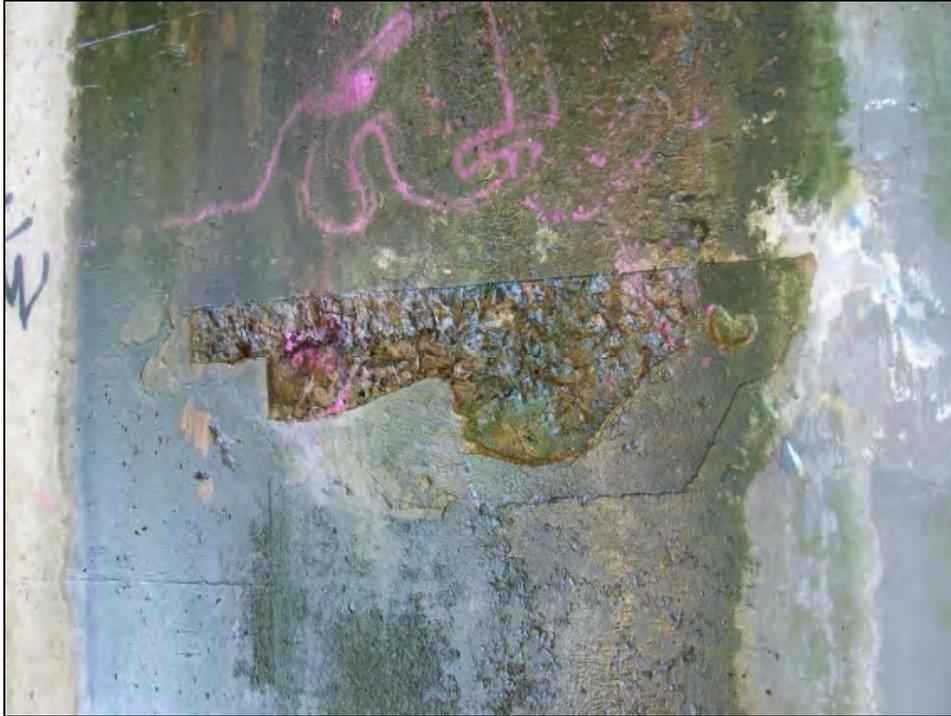
15. Spall toward the bottom of the near left abutment stem.

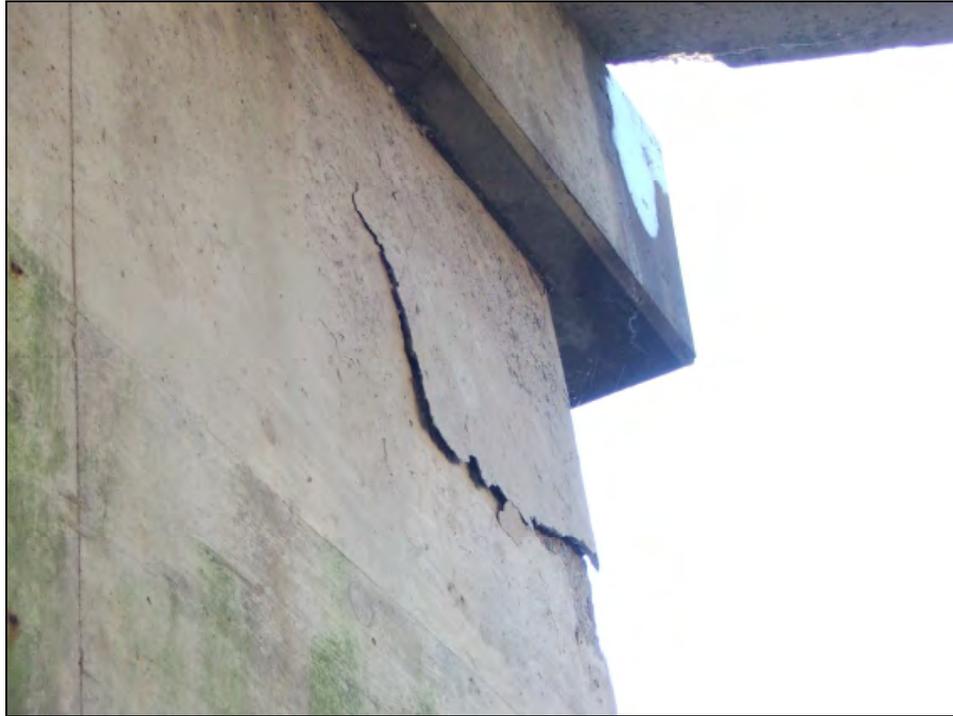
16. Large delamination at the top far left face of pier 1.

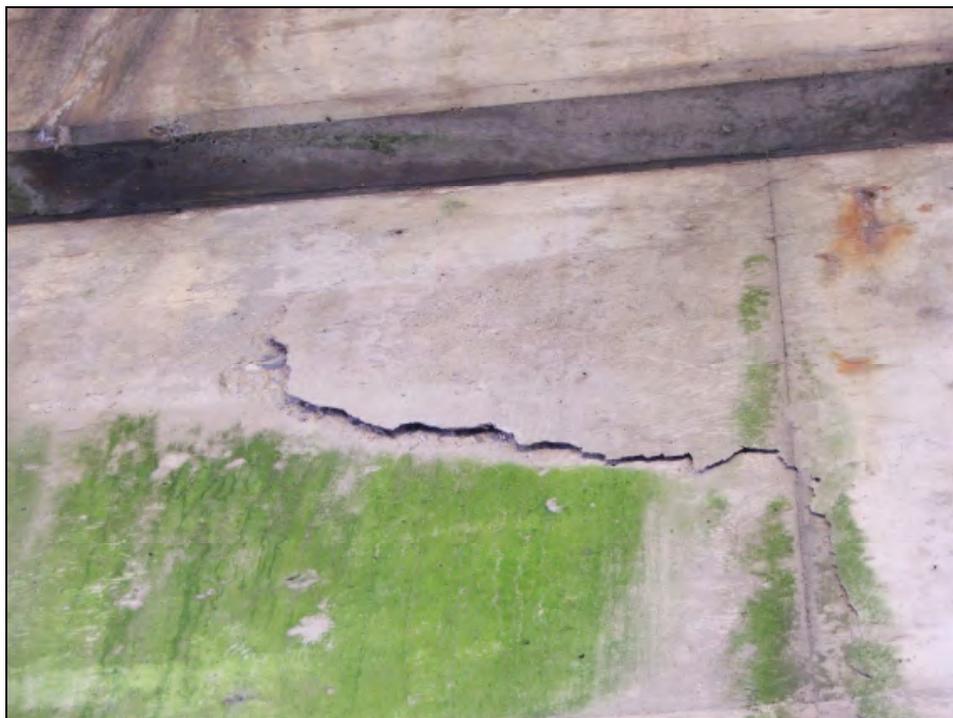
17. Large delamination at the top far middle face of pier 1.

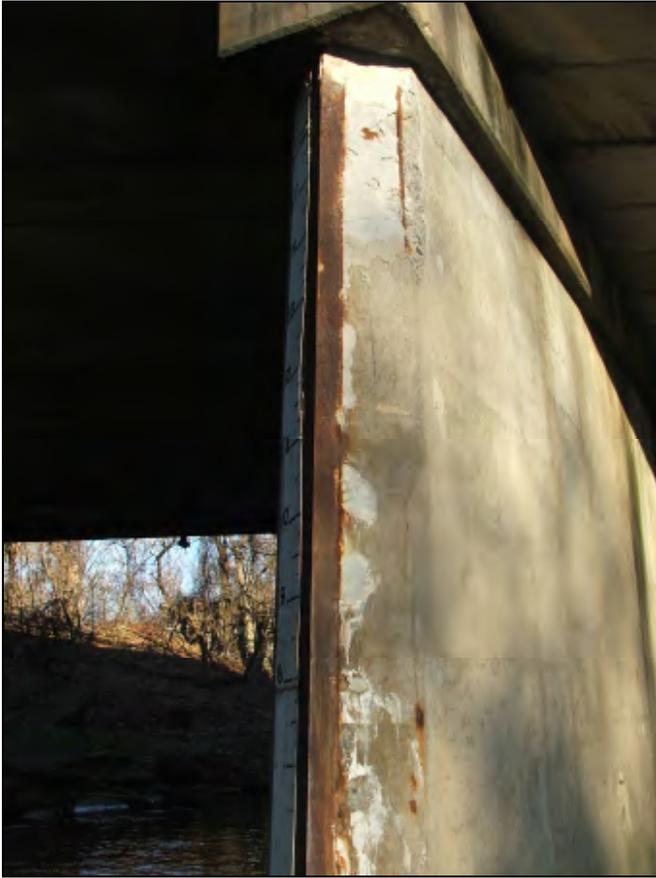
18. Typical spalls and cracked patches at the upstream noses of the piers.

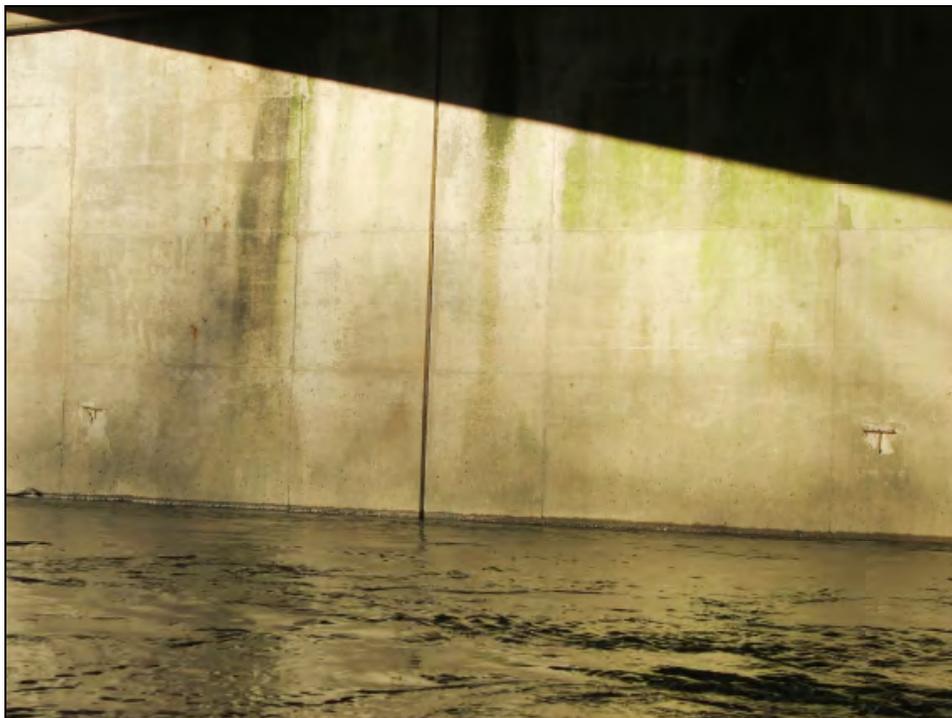
19. Typical small patches (spalling) at pier 2.

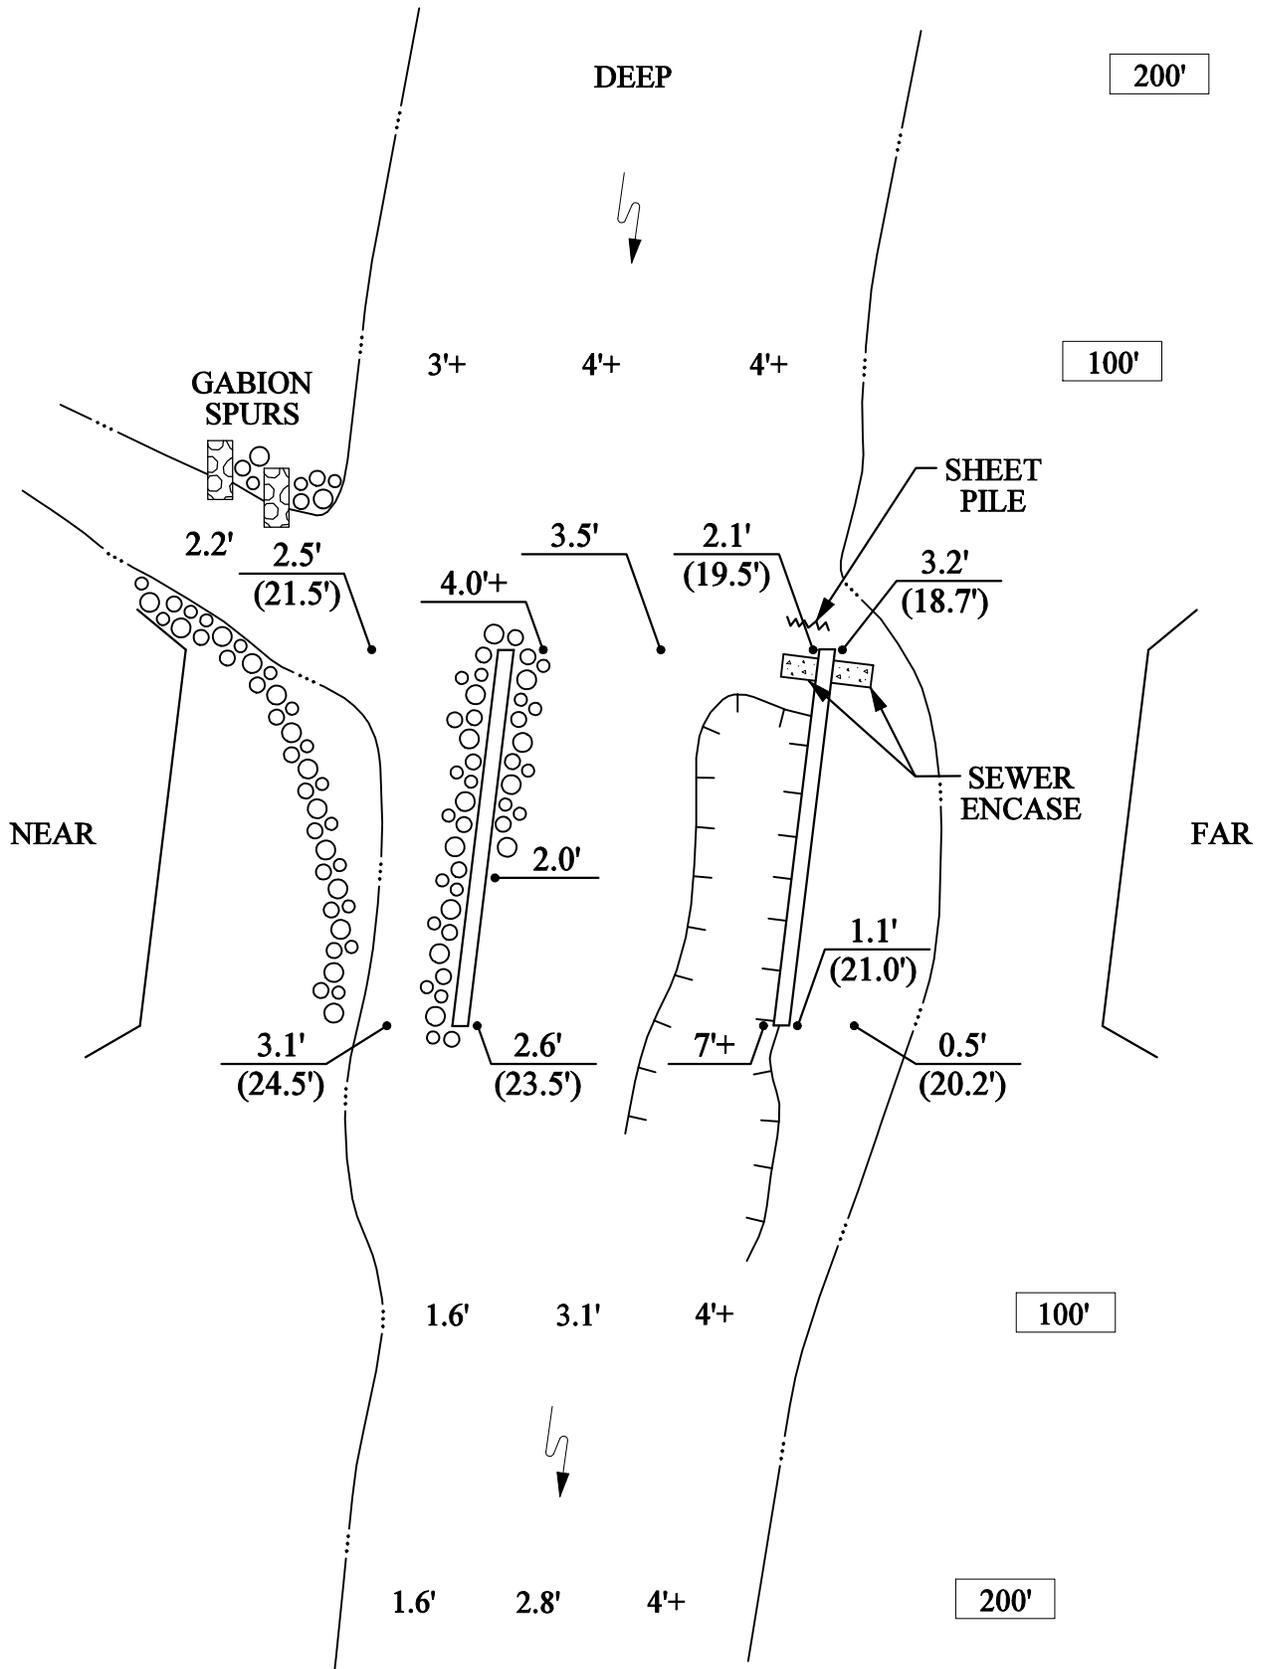
**WATERWAY SKETCH**

**Channel:** fairly straight - mostly through span 2 (some flow around pier 1);  
scour across NR 2/3 of pier 2 - 7'+ water depth
