COUNTY OF LEHIGH

SPILLMAN FARMER ARCHITECTS  
MASONRY PRESERVATION SERVICES  
KEAST & HOOD STRUCTURAL ENGINEERS

## SAYLOR CEMENT KILNS COPLAY, PENNSYLVANIA

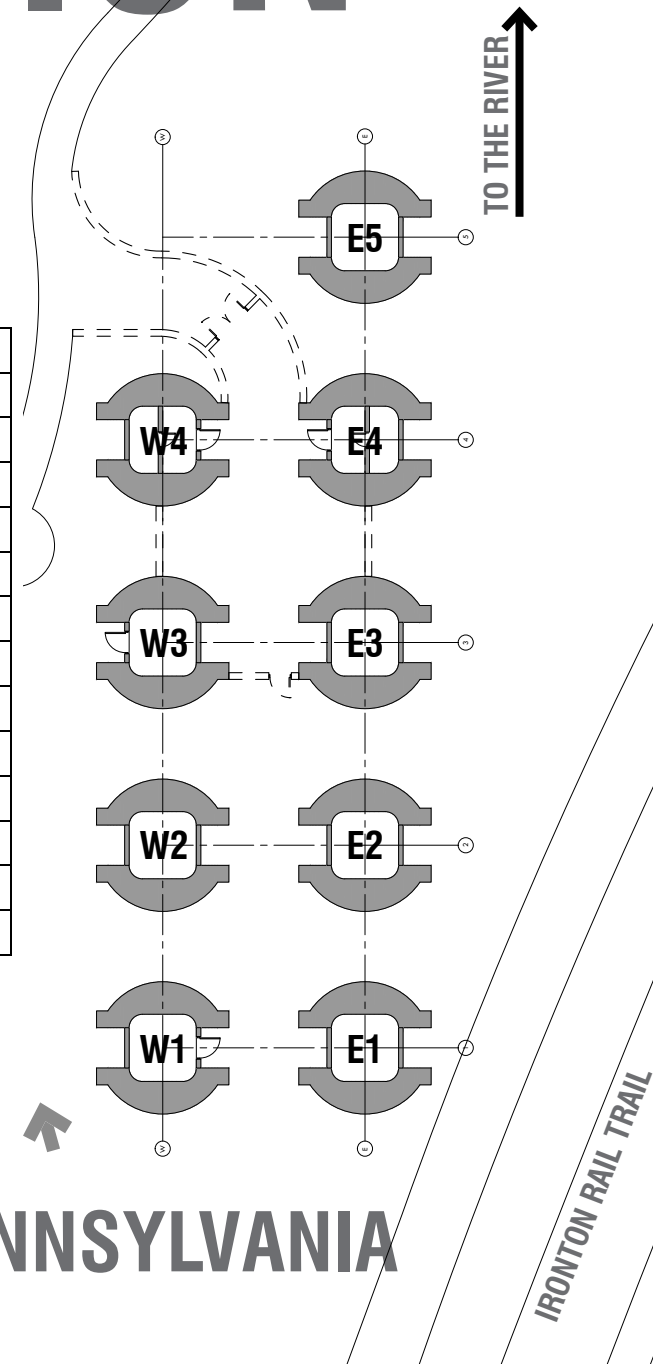
Structural Concern	Kiln Number (listed best to worst)								
	W1	E1	E2	W3	E4	E5	E3	W2	W4
Open Joints	X	X	X	X	X	X	X	X	X
Plant Growth	X	X	X	X	X	X	X	X	X
Embedded Corroded Steel	X	X	X	X	X	X	X	X	X
Cracks in Brick Veneer		X	X	X	X	X	X	X	X
Bulging Brick Veneer			X	X	X	X	X	X	X
Loose Metal Flashing	X	X	X	X	X	X	X	X	X
Deteriorated Cement Parging				X	X	X	X	X	X
Delaminating Brick Veneer				X	X	X	X	X	X
Tree Growth						X	X		
Brick Veneer Collapse							X	X	X
Brick Wall Collapse								X	X

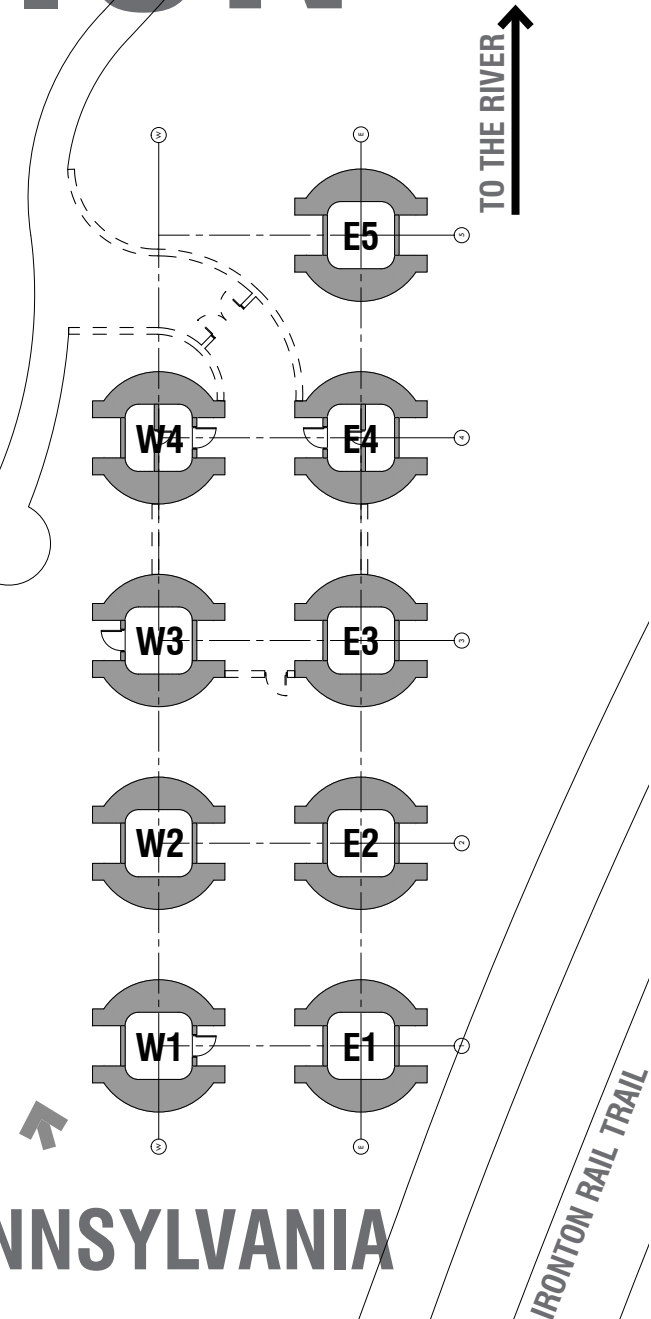
KILN STABILIZATION:  
LEAST EXPENSIVE TO MOST EXPENSIVE

W1  
E1  
E2  
W3  
E4  
E5  
E3  
W4  
W2
